Technical Service Bulletin

94 High beam inoperative

94 14 34 2036670/1 March 7, 2014.

Model(s)	Year	VIN Range	Vehicle-Specific Equipment
Q5	2013 - 2013	All	Not applicable

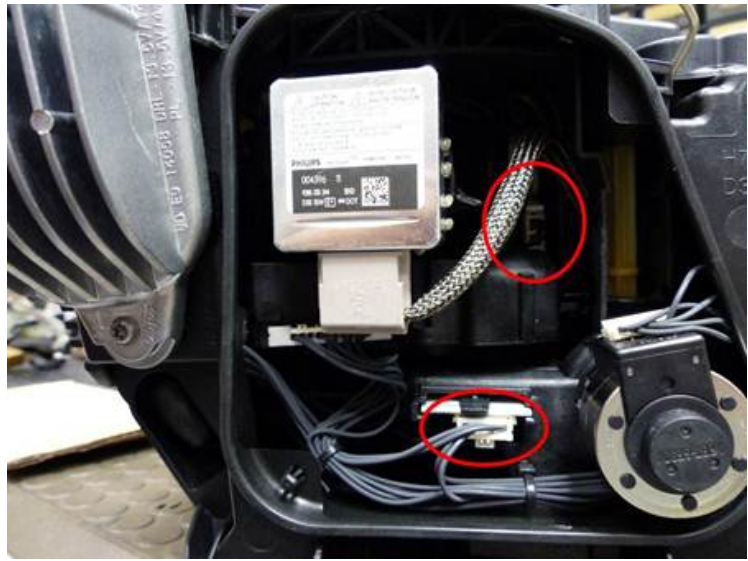
The connection for the high beam shutter is not connected in the affected headlight.

Figure 1. Connectors to be checked.

3. If any connector is loose, inspect it for damage. If no damage is found, re-secure the connector. If it cannot be re-secured, replace the headlight.

When re-securing the connection, do not use a screwdriver or other metal object.
