This Service Information bulletin supersedes SI B63 08 14 **dated May 2014.**

**Active Headlight Control Malfunction in Both Headlights**

F30 (3 Series)

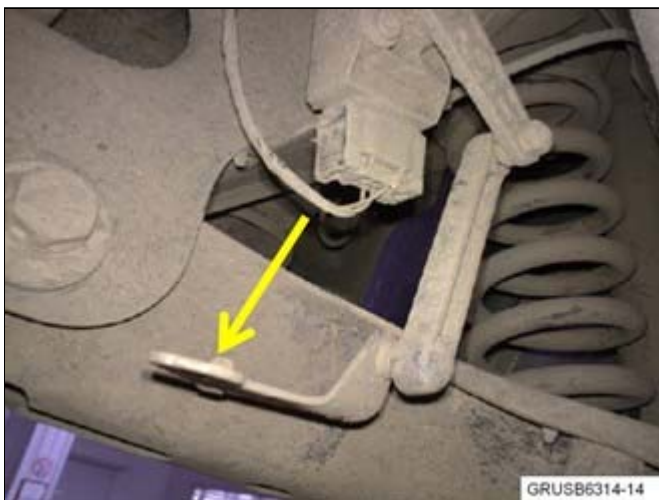
Broken mounting bolt holding on the rear height sensor bracket

1. **NEW** Inspect the rear height sensor, located in the left rear of the vehicle as shown. If the sensor bracket is hanging loose, the hex mounting bolt has broken.
