## TT345C: ADVANCED AUDIO SYSTEM INFORMATION

April 4, 2014

SB-10055746-7880

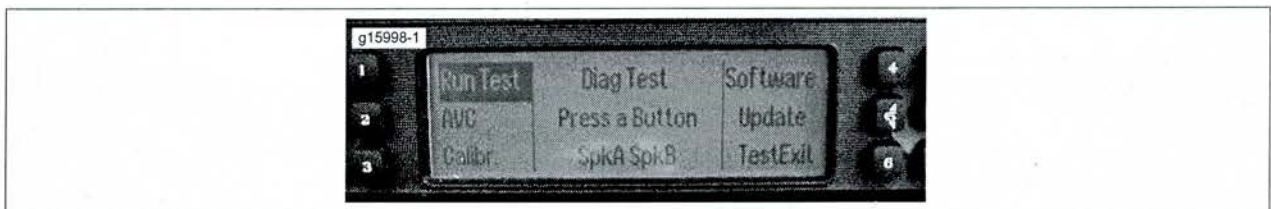
See Figure 1. Self Diagnostics provides a quick check to see if there are any current issues or DTCs recorded. It also provides the ability to check for proper operation of AAS handlebar and passenger switches.

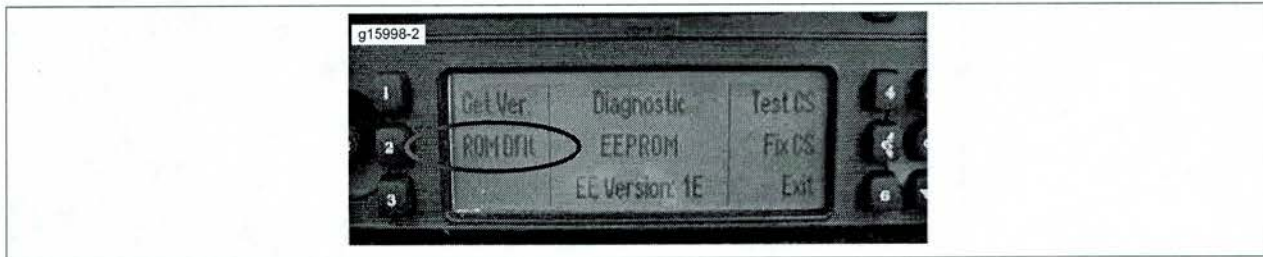
**Figure 2. ROM Default Reset**

See Figure 2. ROM Default Reset returns the radio to base settings. Always perform this reset to eliminate possible user-induced issues such as low volume, low or no display visibility, etc. before ordering a replacement radio.

1. With radio turned ON (AM or FM), press soft keys 1, 3 and OK at the same time and release.
2. Press the UP arrow two times.
3. Press soft key 2 (ROM Dflt) once.
4. Turn ignition off for 30 seconds.

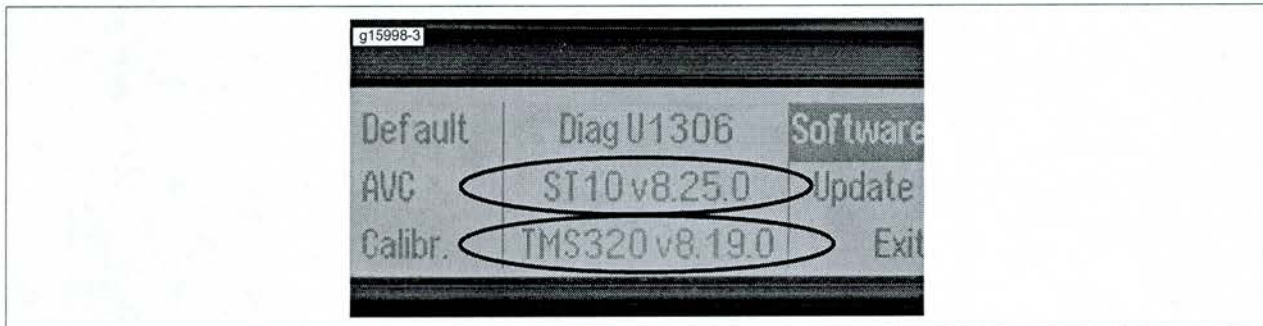
**Figure 3. Software Update**

1. See Figure 3. Access by holding any two preset buttons (1-5) in while powering up the radio. Wait for diagnostics screen to appear, then release the buttons.
2. Press button 4 to see the current software version in the radio.

In earlier software versions, both ST10 and TMS320 lines would be at the same level. Software versions above 8.19 may only change the ST10 to the higher number. The TMS320 may stay at 8.19 which is acceptable.

If a software update is needed, press button 5 (Update) and insert the software update CD when prompted. The rest of the process is automatic and may take up to 10 minutes. After completion,

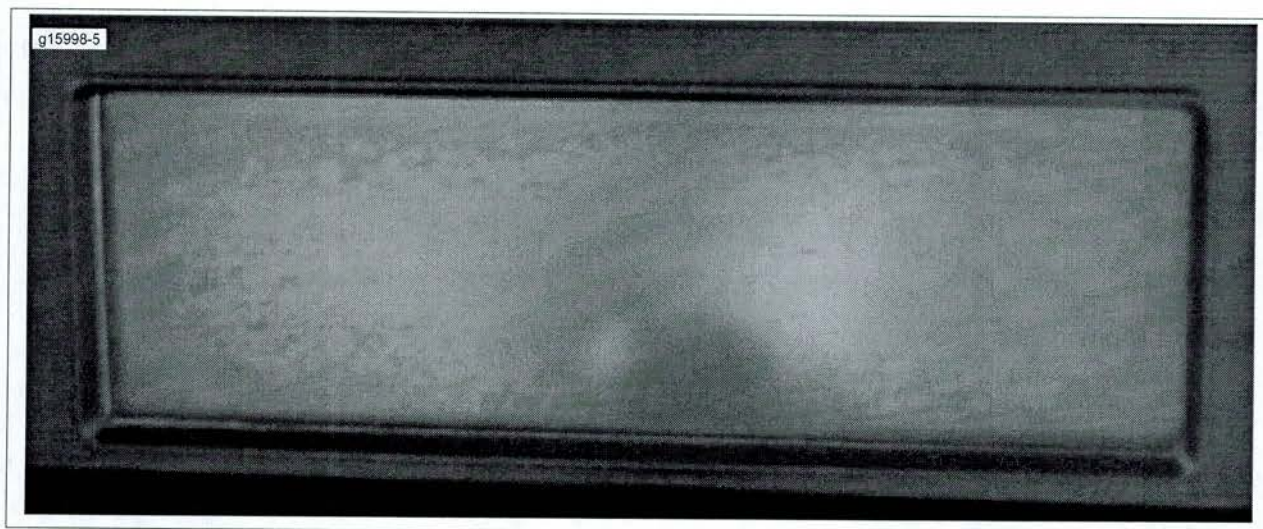
**Figure 4. Damaged Display**

- See Figure 4. Certain chemicals, including gasoline, when spilled or splashed on the display will cause the appearance of tiny spots or bubbles. This is not considered a warranty situation. Testing has shown that Novus No. 2 Scratch Remover (available through P&A) will remove the outer anti-glare coating and restore the appearance of the display. The display is coated on both sides, so glare should not be an issue.

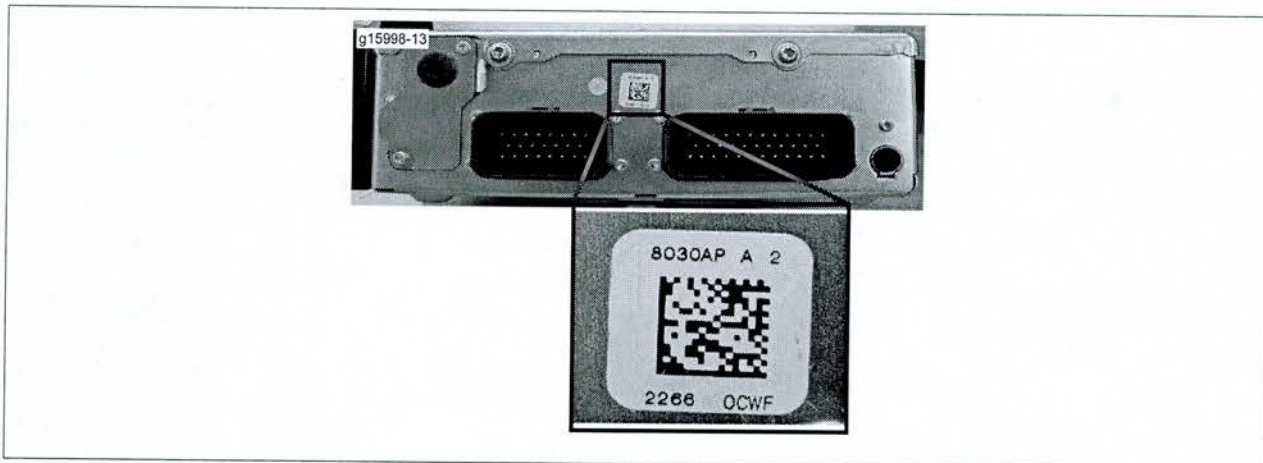
Figure 5. Serial Number Location

When sending a radio for repair or warranty replacement, it is recommended that the serial number from the tag on the defective radio be recorded and kept with the vehicle repair records. Figure 5 shows a serial number of 8030AP A2 2266 OCWF
