# TECHNICAL BULLETIN

## LTB00566NAS2

Fuel Gauge Operation / DTC U0128-00 Stored

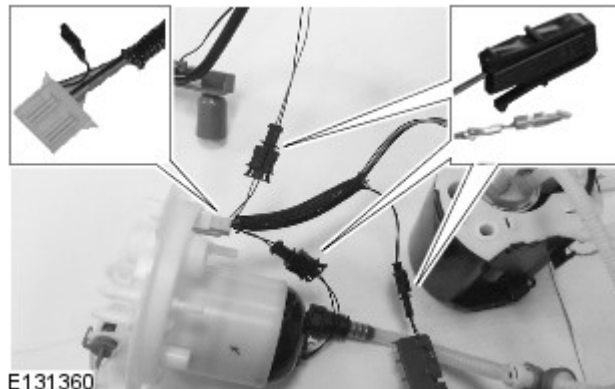
**NOTE: Typical in-tank fuel module and sender components; not all derivatives will have the same number of connectors.**

Check the internal components for backed out pins/wires.

- If no backed-out pins/wires are found, continue to the next step.
  - If any backed-out pins/wires are found, repair as necessary.
6. Using SDD, measure the resistance of the fuel gauge sending units.
  7. Compare values to the resistance chart (see TOPIx Workshop Manual, Section 310-01).
    - If the sending units resistance value is correct, continue to the next step.
    - If the sending units resistance value is not correct, replace the faulty units. Must be performed as a
