Technical Bulletin

Model(s)	Year(s)	Eng. Code(s)	Trans. Code(s)	VIN Range From	VIN Range To
Eos	2006 - 2007	2.0L (BPY)	All	All	All
GTI	2006 - 2007	2.0L (BPY)	All	All	All
Jetta (A5)	2005 - 2007	2.0L (BPY)	All	All	All
Passat, Passat Wagon	2006 - 2007	2.0L (BPY)	All	All	All

15 14 01 March 11, 2014 2015153 Supersedes T. B. V151202 dated August 20, 2012 to update technical diagnosis labor operation in warranty table and update the Intake camshaft suffix number.

MIL ON, DTC P0087, P1093 or P2293 Stored in ECM Fault Memory

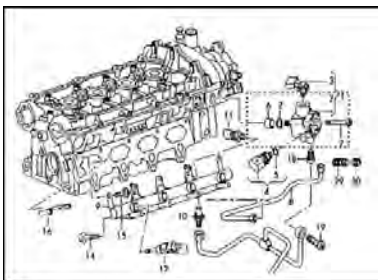
Figure 1

Remove the high pressure fuel pump and visually inspect:

1. Base surface of the cam follower -6- in contact with the camshaft lobe.
2. Tip of the high pressure fuel pump plunger.

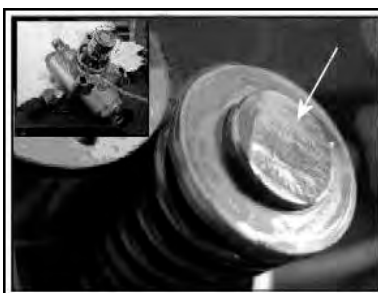
Figure 2

Inspect the tip of the high pressure fuel pump plunger (Figure 2) for excessive wear.

High pressure fuel pump plunger damage is only possible if the cam follower base has a hole in it as seen in figure 3 inset -A-, and the plunger tip has come in direct contact with the camshaft lobe (figure 4).

If plunger tip of fuel pump is **NOT WORN**, **DO NOT REPLACE** the fuel pump.

If excessive wear is found the high pressure pump must also be replaced, see Group 20 Fuel Supply in ElsaWeb.
