Technical Service Bulletin

94 Headlight flickers, flickering, or warning on in cluster (all xenon headlights)

94 14 36 2029194/5 April 2, 2014. Supersedes Technical Service Bulletin Group 94 number 13-10 dated March 4, 2013 for reasons listed below.

Model(s)	Year	VIN Range	Vehicle-Specific Equipment
Q7	2010 - 2015	All	Premium Plus and Prestige

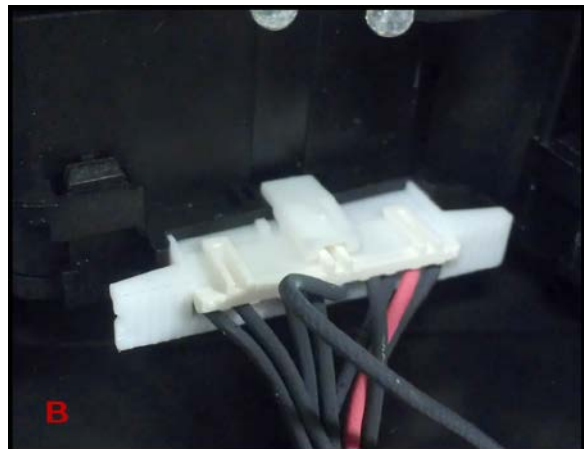
Figure 3. Connector “B” shown off-center.

- Connector “A” can be seated, but not fully engaged (Figure 2). It is important to hold the projector housing when this connector is pushed, otherwise, the projector will swivel.
- Connector “B” can be fully locked into place, but be rotated 5-10 degrees off-center (Figure 3). Ensure that the harness connector is seated parallel to the connector housing on the headlamp.
- Connector “C” (Figure 4) is located behind the motor mechanism, which rests below the projector lens. It is a very small two-pin connector that should be adjusted cautiously. If it becomes fully disconnected, it is very difficult to re-connect without the use of special tools. Use your finger or a small set of bent pliers to pull the connector toward you in order to fully seat it.

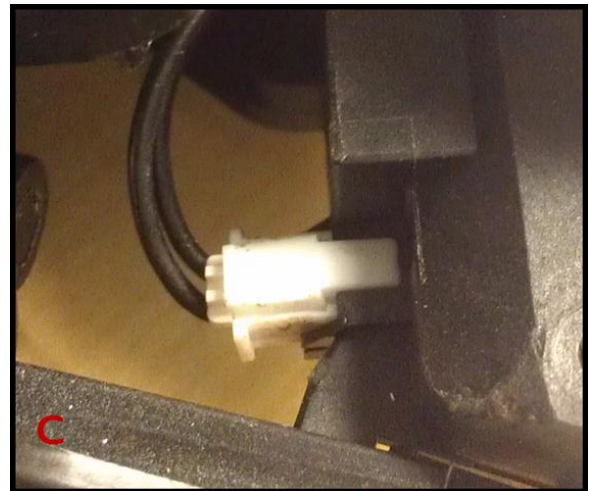
Figure 4. Connector “C” shown in the locked position.
