Bulletin No.: PIE0295A

Service Bulletin

Subject: Engineering Information – Engine Cranks/No Start, DTCs P00C6 or P0011 Set

Models: 2014 Chevrolet Corvette, Silverado 1500
2015 Chevrolet Suburban, Tahoe
2014 GMC Sierra 1500
2015 GMC Yukon, Yukon XL
Equipped with 4.3L, 5.3L, 6.2L Engine (RPOs LV3, L83, L86, LT1)

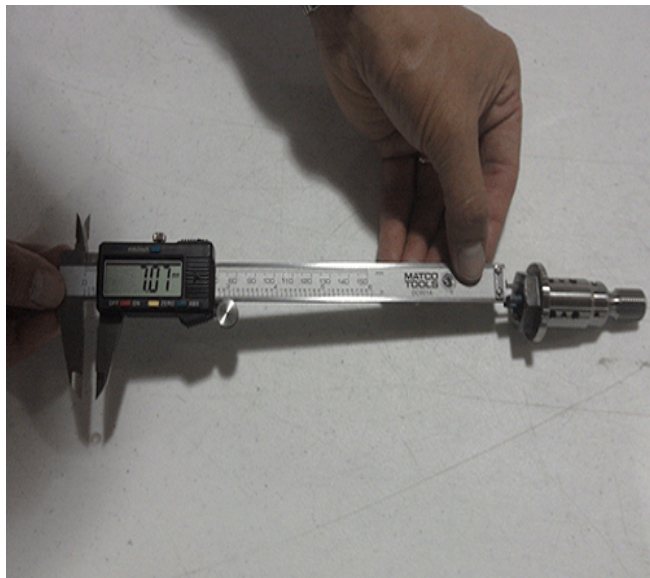
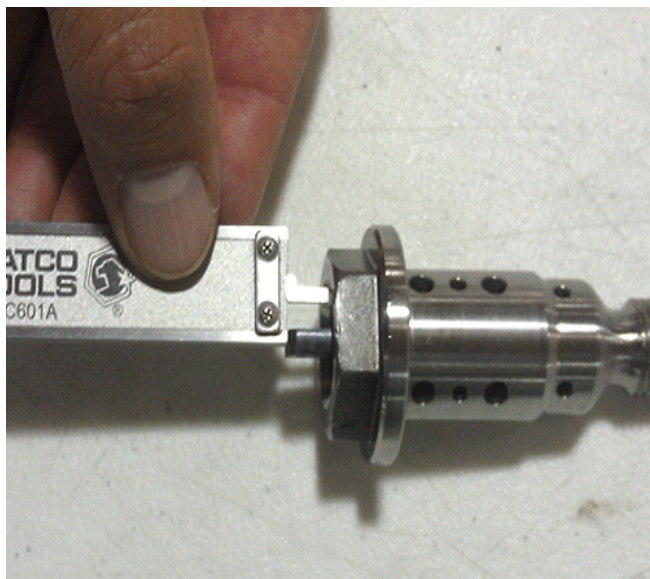
Note: Camshaft position actuator solenoid valve shown off engine for illustration purposes. Measurement must be done on engine.

2. Before removing the camshaft position actuator solenoid valve, measure the height of the center portion (called the spool) to the outer body with calipers. DO NOT apply force or pressure on the center portion. A stuck valve will measure less than 6 mm.
3. Record the measurement on the job card and include with the valve in the shipping package.
