SB-10055836-9757

Reference	SSM70638
Models	LR4 / L319 Range Rover Sport / L494 Range Rover (All New) / L405
Title	TPMS Sensor Not Operating Correctly When New Service Part Fitted
Category	Chassis
Last modified	06-Jan-2014 00:00:00
Symptom	306000 Tyres/Wheels

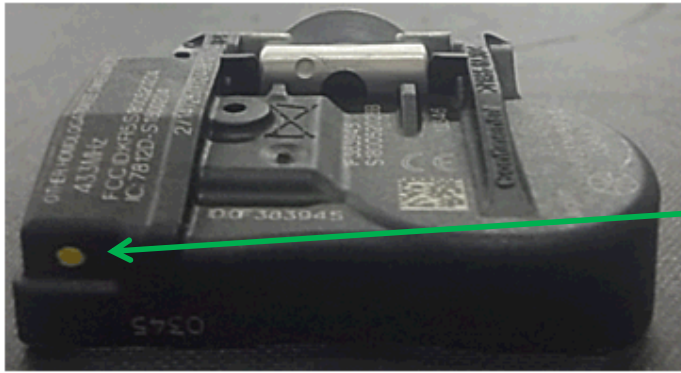
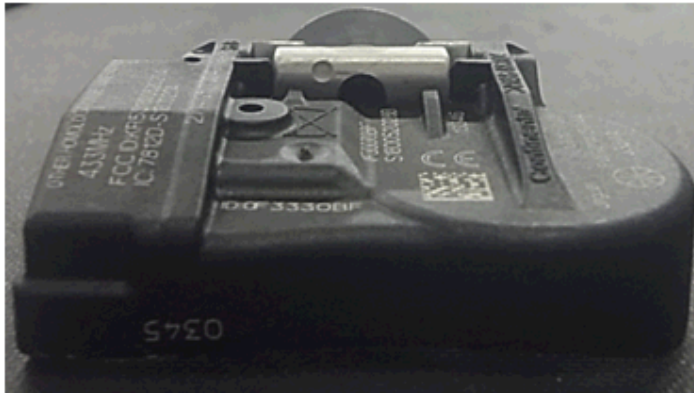
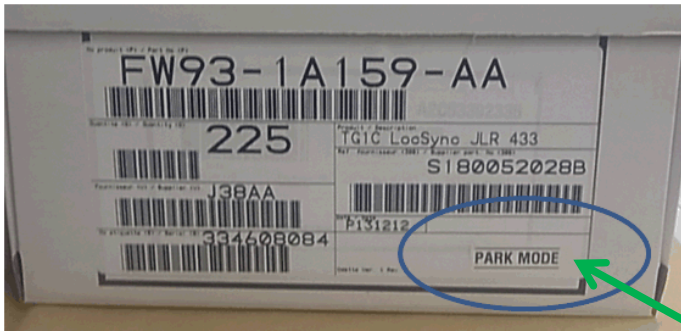
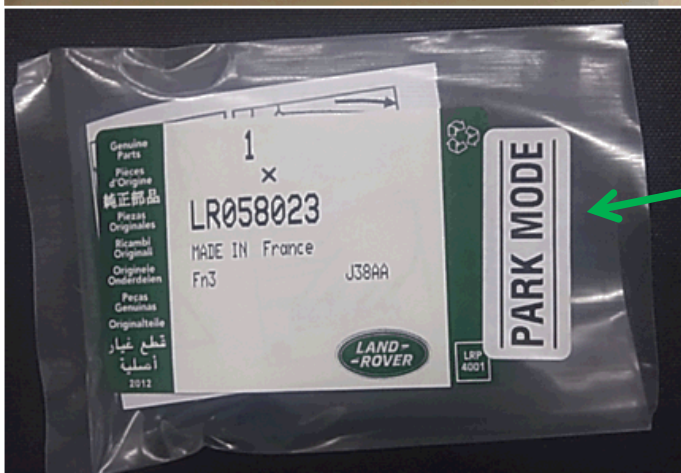
tpms attachment.pdf

Latest parts will be supplied correct mode i.e. in "park mode", this can be identified with a yellow dot on the part itself, and with "park mode" on the packing (see attachment.)

If a part is received in "ship mode" it must not to be used, and should be returned, any additional consequential parts or time incurred shoul be submitted under a parts warranty claim.
