Bulletin No.: 13434B
Date: May 2014

SB-10055837-4529

SUBJECT: Air Conditioning System Inoperative or Cools Intermittently

MODELS: 2013-2014 Chevrolet Spark

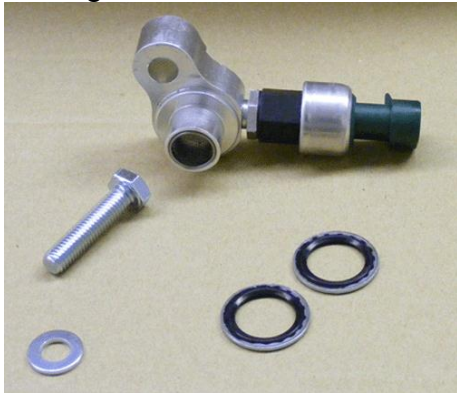
3782696

A/C Refrigerant Filter Kit

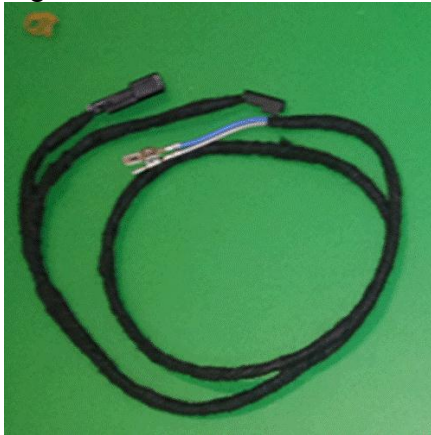
3782704

Wiring Harness Kit
