Technical Service Bulletin

91 Parking aid system does not work (DTC 1549, 1626, 1627, 1628, and/or 1629)

91 14 31 2023006/3 April 7, 2014. Supersedes Technical Service Bulletin Group 91 number 11-08 dated August 22, 2011 for reasons listed below.

Model(s)	Year	VIN Range	Vehicle-Specific Equipment
Q5	2009 - 2016	All	Front parking aid

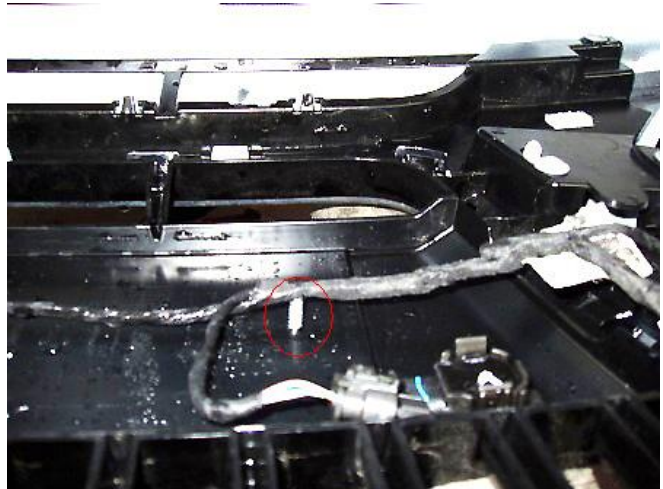
- The parking aid system does not work.
- One or more of the following DTCs may be logged in parking aid control unit, J446 (address word 10), for disruption/short circuit to ground:
 - **DTC 1549** (Supply voltage for parking aid sensor)
 - **DTC 1626** (Right front parking aid sensor)
 - **DTC 1627** (Right front center parking aid sensor)
 - **DTC 1628** (Left front center parking aid sensor)
 - **DTC 1629** (Left front parking aid sensor)

The wire harness for the parking aid system may have been damaged when the front license plate frame was installed (Figure 1).

Figure 1. Damage to the wire harness for the parking aid system.

Repair the wire harness as necessary.
