Bulletin No.: P11219

**Subject:** Turbocharger Cracks in Inlet Port Center Web Area

**Models:** 2014-2015 Buick Regal  
2013-2015 Cadillac ATS  
2014-2015 Cadillac CTS (VIN A)  
2013-2015 Chevrolet Malibu  
Equipped with Turbocharged 2.0L Engine — RPO LTG

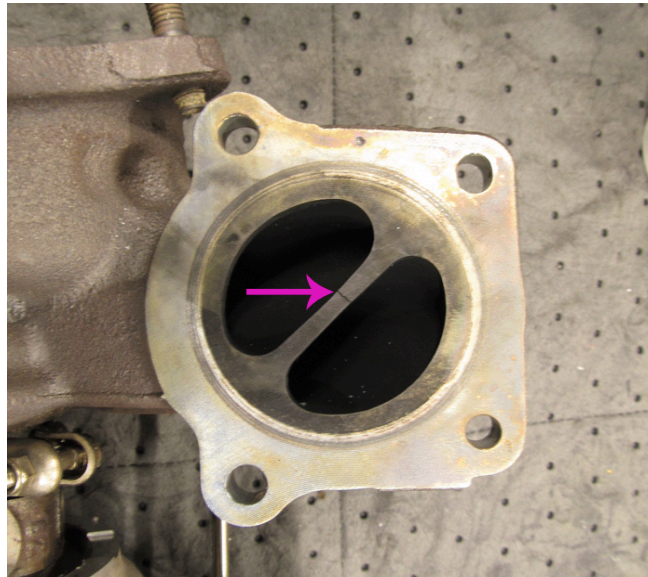
Review the following graphics for views of TC cracks that **DO NOT** require TC replacement:

The appearance of cracks in the center section of the turbocharger **DO NOT** affect the performance of the TC. The TC should not be replaced for cracks in this section.
