SB-10055855-1429

Technical Service Bulletin

94 Daytime running light (DRL) inoperative (DTC 02895 or 02897)

94 14 38 2032184/3 April 7, 2014. Supersedes Technical Service Bulletin Group 94 number 13-21 dated July 9, 2013 for reasons listed below.

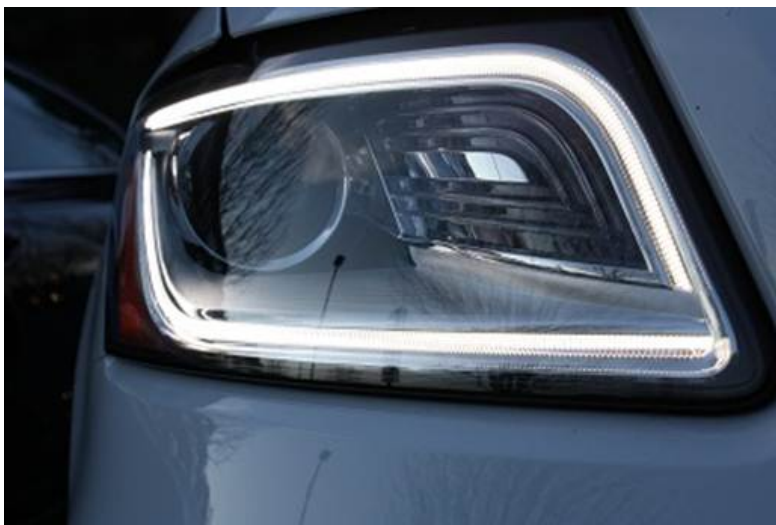
The MY2013+ Audi Q5 LED DRLs use light-emitting “pipes” or “guides” instead of multiple, individual LEDs. There are two light pipes per headlight. Each light pipe uses a single LED for illumination (Figure 1).

Figure 1. Upper and Lower light pipes illuminated.

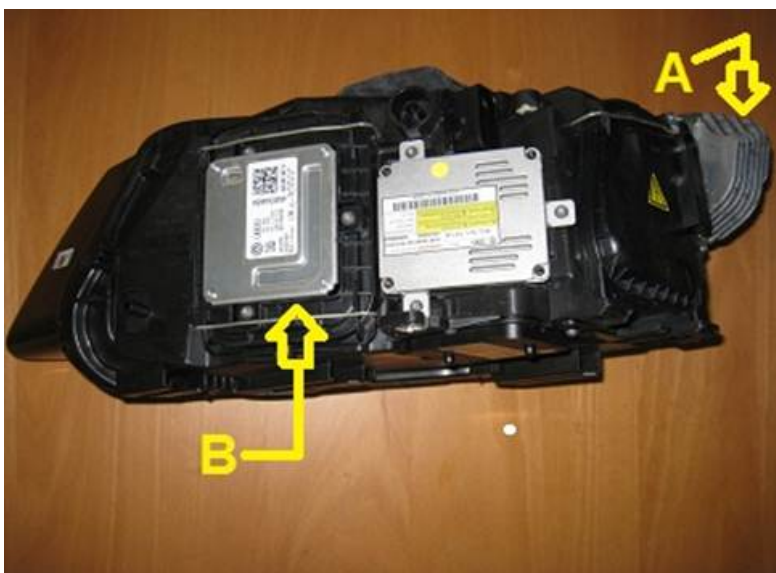
The LEDs with heatsinks are contained in a single module (Figure 2, A) mounted to the outer backside of each headlight.

Figure 2. Backside of headlight with LED heat sink (A) and LED control module (B).

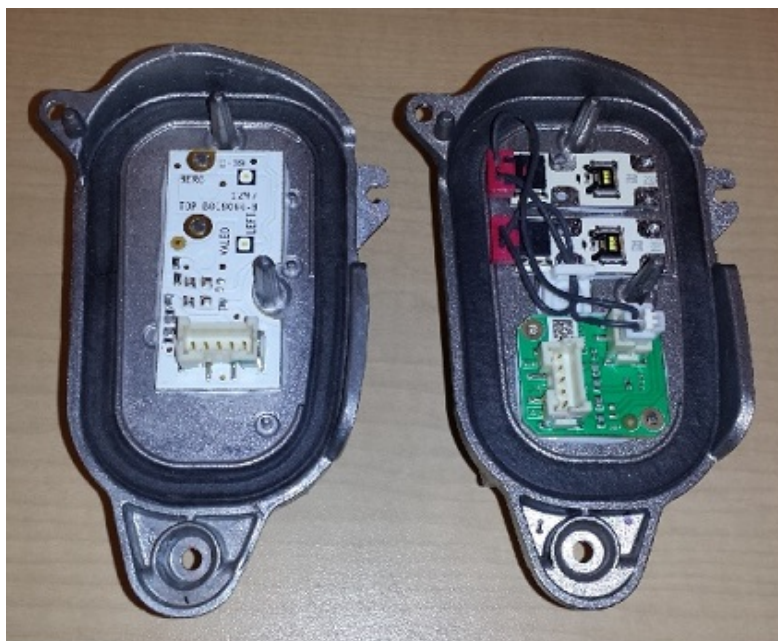
As of March 12th, 2013 production, the LED unit with heat sink has been updated (Figure 3). If a failure occurs, these parts do *not* need to be replaced in pairs.

Figure 3. Current (left) and early (right) style LED DRL units.

The appearance of the replacement part for the LED DRL has changed, but functionality is the same. If an LED DRL needs to be replaced, they do not need to be replaced as a pair.

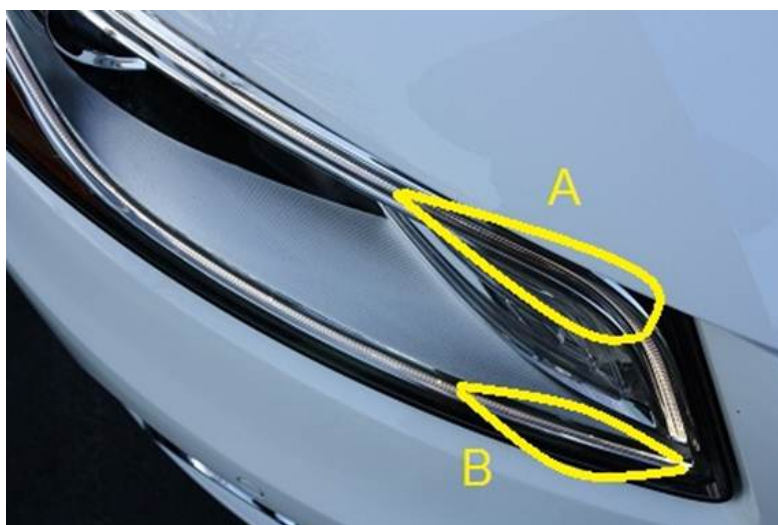
If the customer complaint is that the LED DRLs appear to be partially inoperative, please confirm this complaint while the customer is present. The LED DRL can be perceived as inoperative due to the viewing angle taken by the customer.

- A defect may be perceived for top-down viewing angle (Figure 4).

Figure 4. Upper light pipe perceived defect (A). Lower light pipe perceived defect (B).

Explain to the customer that the LED illumination appears differently to someone standing in front of the vehicle than it appears to oncoming traffic. The viewing angle of someone standing in front of the vehicle will give a visual effect of an LED DRL inoperative or partially-inoperative condition.

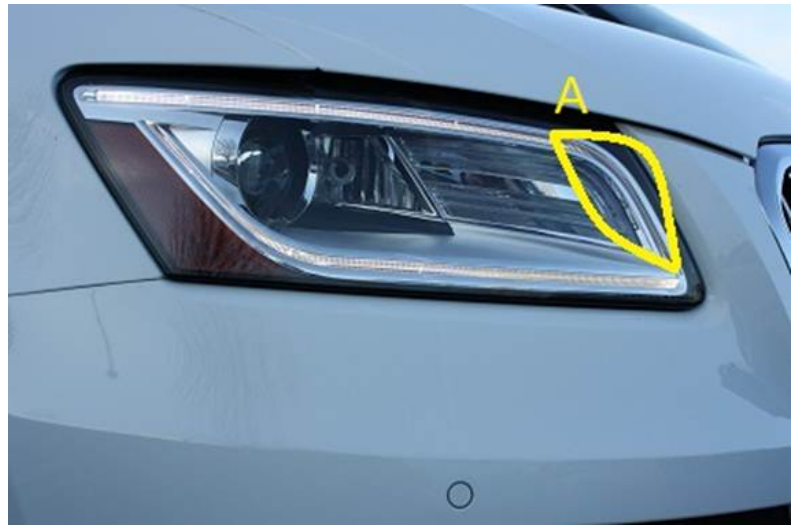
- A defect may be perceived for corner viewing angle (Figure 5).

Figure 5. Upper light pipe perceived defect (A).

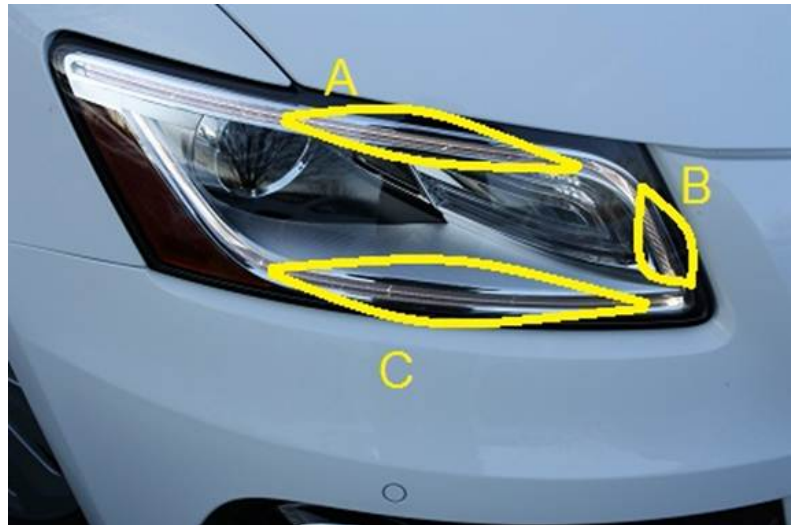
- A defect may be perceived for acute corner viewing angle (Figure 6).

Figure 6. Upper light pipe perceived defect (A, B). Lower light pipe perceived defect (C).

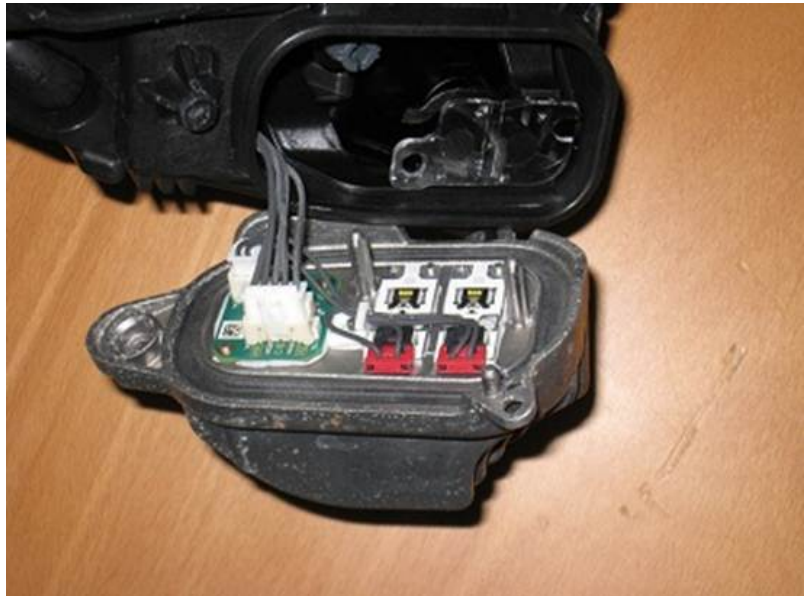
Be extra careful with red surface mount connectors. In general, a repair kit is not available for any internal headlight connectors.

Figure 7: Dual surface mount LED unit exposed.

1. With ignition off, remove DRL control module and check red connector at module. Secure it, if loose. If necessary, remove red connector and reinstall to be sure connector is engaged properly. The wiring harness guide of the red terminal housing may impede connector engagement.
2. Turn ignition on to see if DRL is now operating to specifications. If it is not, proceed to step 3.
3. Remove headlight(s) according to the instructions in ElsaWeb. See *Repair Manual >> Electrical System >> Electrical Equipment >> 94 Exterior Lights, Switches >> Removal and Installation*.
4. With ignition off, remove LED DRL unit with heat sink from headlight housing (Figure 7).
5. With ignition off, inspect and secure all electrical connectors, if loose. Remove and secure the white connectors, even if they do not appear to be loose.
