# Technical Bulletin

Model(s)	Year(s)	Eng. Code(s)	Trans. Code(s)	VIN Range From	VIN Range To
Jetta, Jetta Wagon (A5)	2009	2.0L TDI (CBEA)	All	All	All
Jetta Sedan (A5), Golf, Golf Wagon, Jetta SportWagen (A6)	2010	2.0L TDI (CJAA)	All	All	All
Jetta Sedan, Golf, Golf Wagon, Jetta SportWagen (A6)	2011-2014	2.0L TDI (CJAA)	All	All	All

**21 14 03** April 24, 2014 **2026771** Supersedes T. B. V211108 dated November 16, 2011 to include additional model year applicability.

### Engine Lacks Performance, Engine Warning Light ON, DTCs P2563, P2564, P0299 or P20D8 Stored in ECM Fault Memory

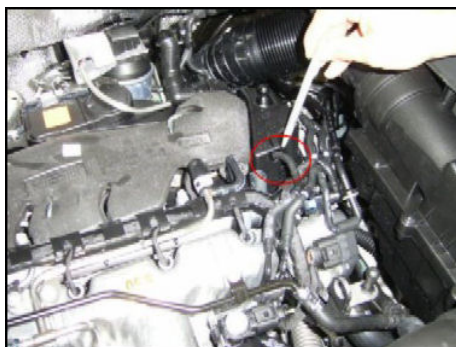
Figure 1

Hose not inserted into the vacuum container.

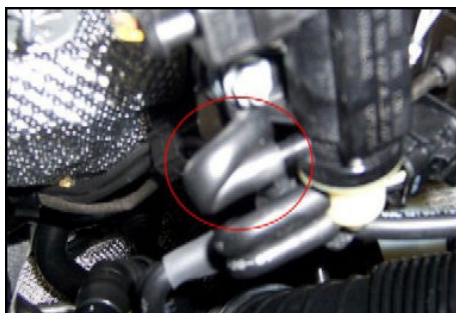
Figure 2

Vacuum hose at the solenoid valve, or in the pipe system, is kinked.

- Re-position hoses to avoid pinching. It is not necessary to replace the hoses.

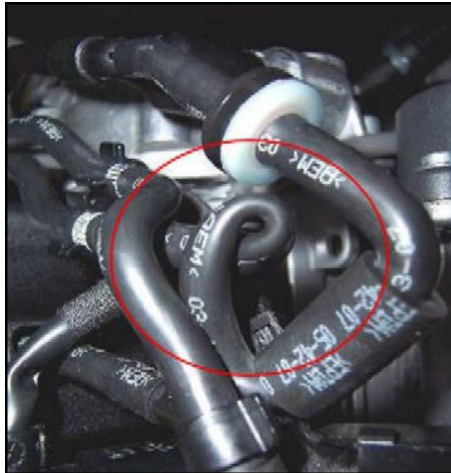
Figure 3

Vacuum hose at the solenoid valve, or in the pipe system, is twisted.

- Re-position hoses to avoid pinching. It is not necessary to replace the hoses.

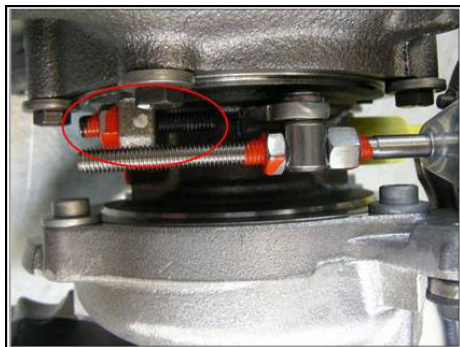
Figure 4

- Inspect the turbocharger stud with clamp nut (min. flow adjustment screw) ( Figure 4).

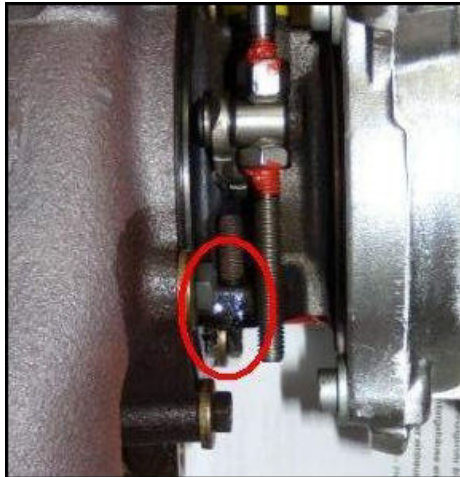
Figure 5

- Inspect the turbo charger to see whether the stud with clamp nut is broken (Figure 5).

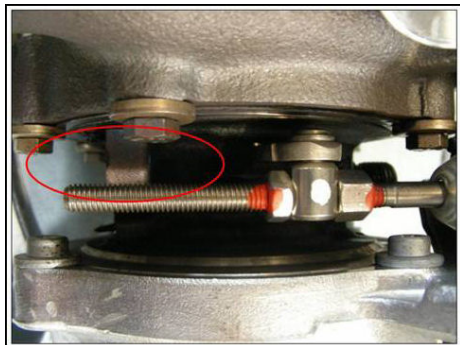
Figure 6

- Inspect the turbo charger to see whether the stud with clamp nut is missing (Figure 6).
- If the stud or clamp nut are missing, replace turbocharger.

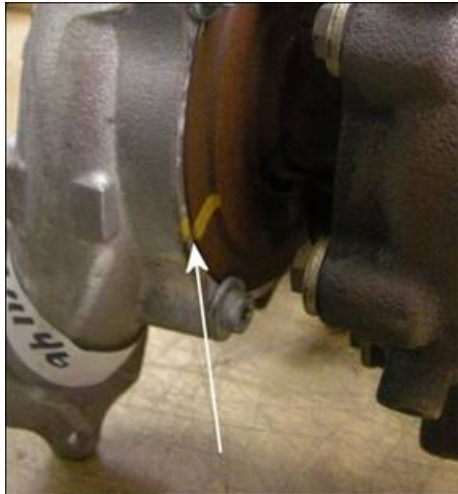
Figure 7

- Carefully inspect the turbocharger housing around the entire housing assembly for an alignment mark (Figure 7). If the alignment mark is misaligned, this indicates that the housing has rotated.
- If misaligned, replace turbocharger.

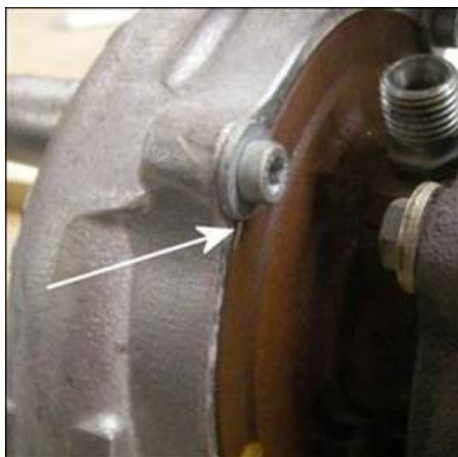
Figure 8

- Carefully inspect the turbocharger housing around the retaining bolts for witness marks (Figure 8), indicating that the housing has rotated.
- If witness marks are present from washers, replace turbocharger.

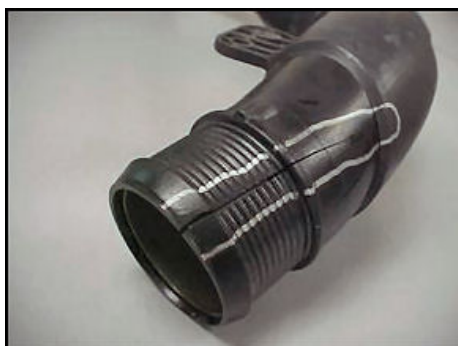
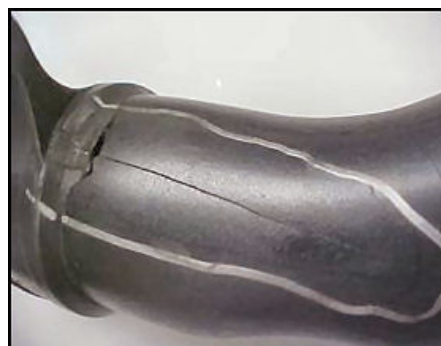
- Inspect the plastic boost pipe that runs from the intake side of the turbocharger to the intercooler for cracks or leaks (Figures 9 and 10).

These cracks can be difficult to see. It may be necessary to pressure test the charge air system according to the repair manual under Engine > Engine Mechanical, Fuel Injection and Glow Plug > 21 turbo charger, G charger =>Diagnosis and Testing => Charge Air System, Checking for Leaks.

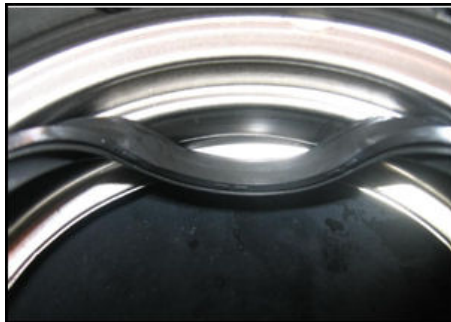
Figure 11

- Inspect the boost pressure hose connections to the intercooler for leaks.
- Ensure that the seals are in the proper position and not damaged (Figure 11). Damaged or missing seals should be replaced. The seals are available separately, it is not necessary to replace the entire hose.

**Pay close attention to this area if DTC P20D8 is recorded in ECM faults.**
