| <b>HYUNDAI</b> NEW THINKING.<br>NEW POSSIBILITIES.<br><br><b>Technical Service Bulletin</b> | GROUP<br><b>CAMPAIGN</b> | NUMBER<br><b>14-01-021</b> |
| SUBJECT: <b>AZERA (HG) B-PILLAR NOISE REPAIR (SERVICE CAMPAIGN TT3)</b> | | |

This bulletin provides the procedure to repair a squeak noise from the driver's side of the vehicle when passing over a speed bump on certain Azera (HG) vehicles.

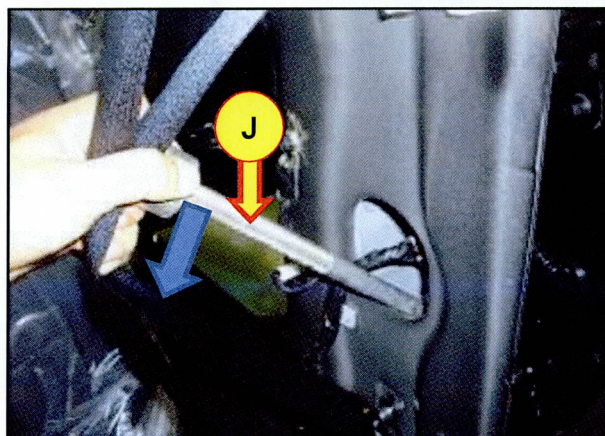
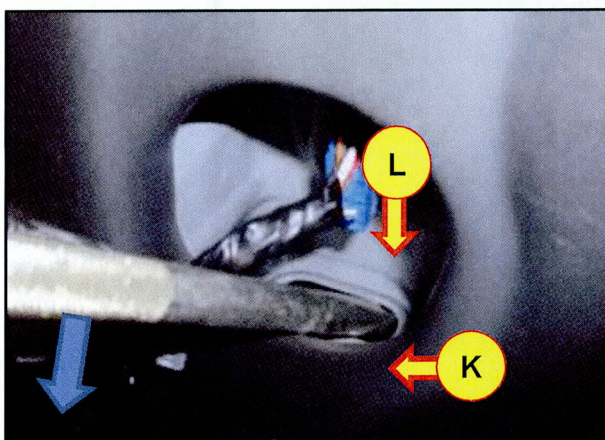
The picture on the right shows a cross-section view to clearly show the gap between the side inner panel (**K**) and the door checker arm bracket (**L**).

7. Carefully pull the pry bar (**J**) in the direction of the blue arrow to secure sufficient gap between the side inner panel (**K**) and the door checker arm bracket (**L**).

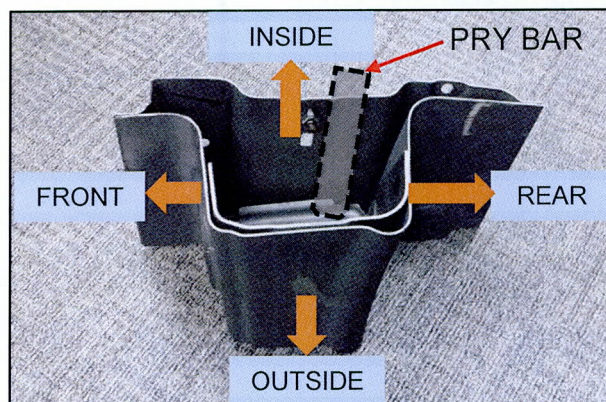
**Gap (M) Specification:**  
More than 2.5 mm (0.1 in).

8. Using a gap ruler or gap gauge, inspect that the gap (**M**) is within specification.
