BTB 51670 (1406)

## MIL Comes On With DTC P0101

SB-10055892-2139

Year	Model	Trim	VIN Range
2013	ILX	Base, Tech with Navigation, and Premium (all 2.0 L with A/T) (no ILX Hybrid)	ALL

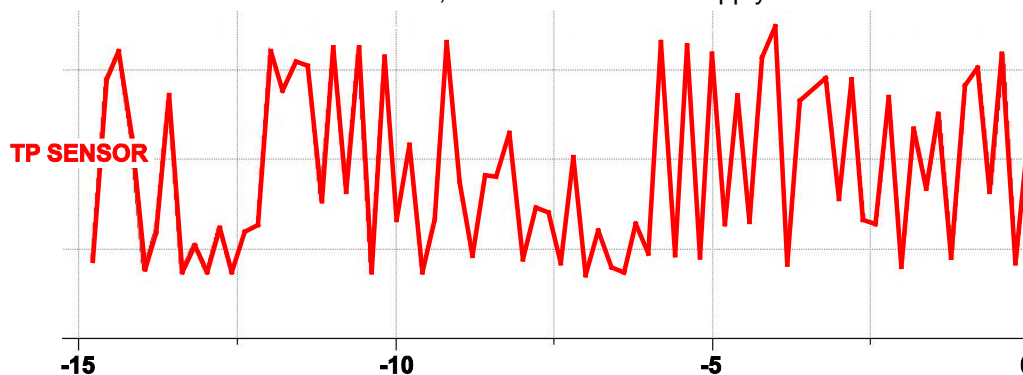
Does the data show the vehicle driving with constant throttle movement like the example shown below?

- If there is **constant throttle movement**, go to REPAIR PROCEDURE.
- If there is little throttle movement, this bulletin does not apply. Continue with normal troubleshooting.

Update the PGM-FI software. Refer to Service Bulletin 01-026, *Updating Control Units/Modules*.
