Service Bulletin No. 407

MODEL	D Series	TYPE	Field Change Program	SECTION/GROUP	12-Suspension	DATE	May 7, 2014
SUBJECT	GABRIEL SHOCK ABSORBER POLYURETHANE BUSHING						
CONDITIONS

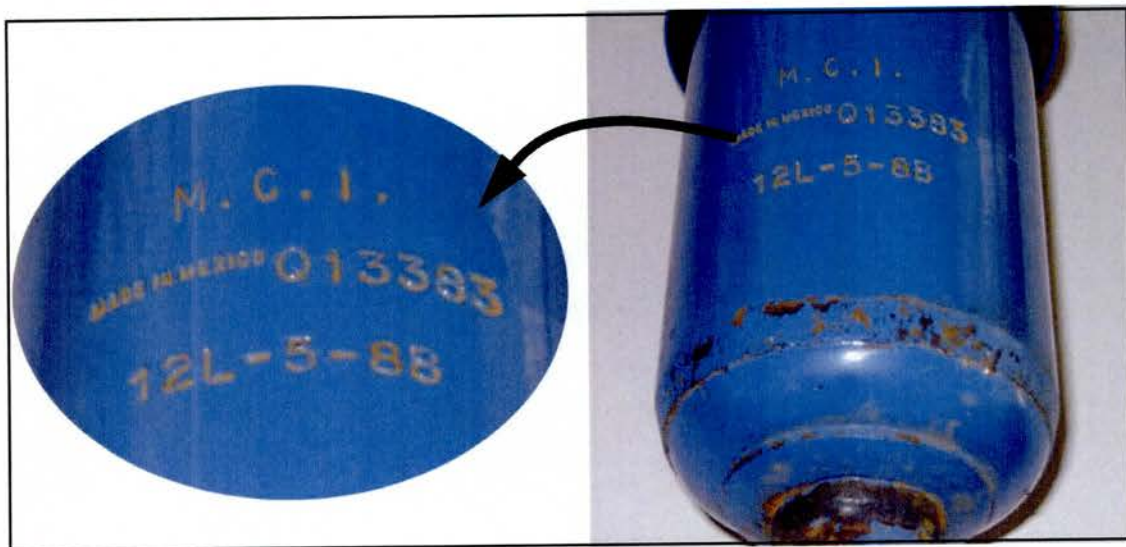
Figure 1.

1. Turn the main battery disconnect switch to the OFF position.
2. Using wheel lifts, lift the coach to the desired work height.
3. Position jack stand supports under the coach frame support points.
4. Carefully lower the axle a little to clear the lower shock absorber stud.
5. Visually inspect and record the date code on the front, drive and tag axle shock absorbers (refer to Figure 1).

If the date code on the shock absorber is stamped Q13 and the bushing is red, proceed to the procedure steps below to replace the bushing.

If the date code on the shock absorber is stamped Q13 and the bushing is not red, no further action is required. Proceed to the next shock absorber.

If the date code on the shock absorber is not stamped Q13, no further action is required regardless of the bushing color. Proceed to the next shock absorber.

Upon inspection, if the shock absorber stud is damaged take a digital photo of the fractured stud as well as the shock absorber part number and the date code (refer to Figure 1). Contact the MCI Fleet Support Technical Center at 1-800-241-2947 for further information regarding replacement.
