SI M33 01 14
Rear Axle

SB-10056090-1237

Delivery Stop/Service Action: Shock Absorber Rear Axle

F56 (MINI Hardtop)

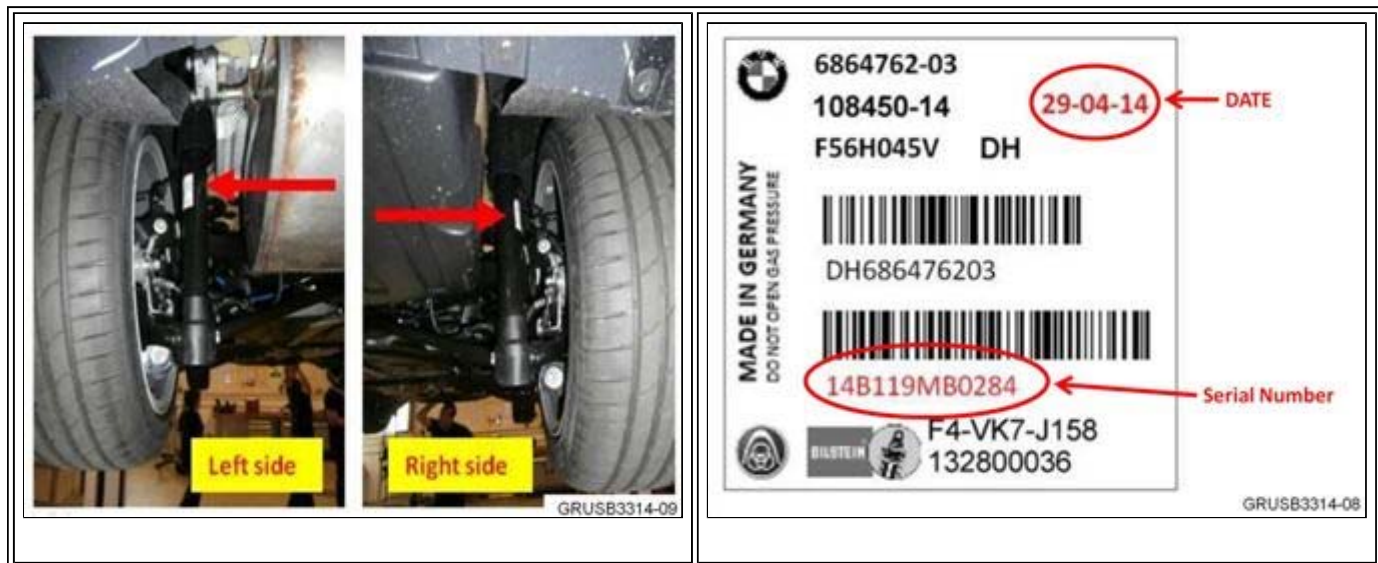
A rear shock absorber with a malfunctioning damper valve may have been fitted into some vehicles.

Important note: In the group of identified vehicles, only four shock absorbers in total are affected. The damper function of these four units is only partially effective.

These four shock absorbers can be identified, based on a particular date and serial number, as seen in the attachment M330114Labels.

Raise the vehicle on a lift and remove both rear wheels. Check the date and serial number on the rear shock absorber labels. If **BOTH** numbers, date and serial number, on the label are identical to one of the labels in the attachment M330114Labels, please note the VIN (Vehicle Identification Number) on the attachment page for the corresponding label and send it back to me via email at tom.digregorio@bmwna.com

Replace both shock absorbers (as a set) on the rear axle per Repair Instruction 37 12 130. See the attachment REP3712130.
