## SB-10056095-9957

**RDC: Incorrect Tire Position Displayed with Air Pressure Drop**

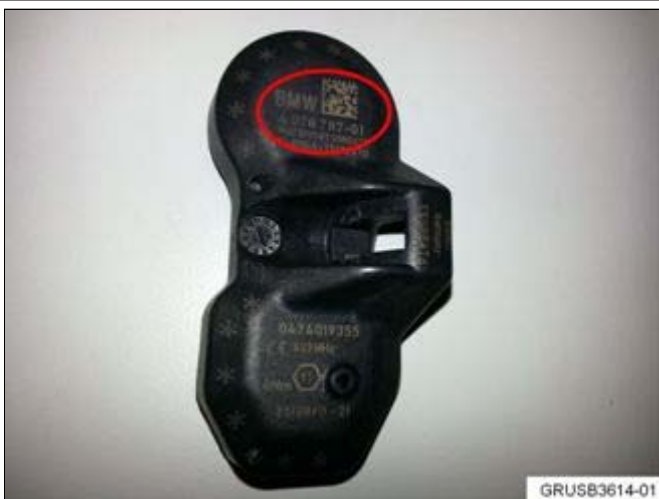
If P/N 4 078 787 or 4 079 152 is found, replace all four wheel electronics with P/N 36 10 6 856 227. If P/N 4 078 787 or 4 079 152 is **NOT** found, proceed as instructed by the ISTA test module and replace the indicated sensor.  
**Note:** P/N 4 078 787 or 4 079 152 is easily identified by the stars that border the face of the wheel electronics, as seen in the picture to the left.
