## SB-10056112-2418

### Aftersales Bulletin

Area **Service Information**  
Subject Urgent: 00 51 42 03 00 RR4, RR4L and RR5 Cooler Air Guide Check (excluding Japan and Australia)  
Group 00 51  
Reference 00 06 14  
Published date 06 June 2014  
Version 1  
Department Service Operations / POM  
Recipients All Service Managers, Aftersales Managers and Service Technicians of Rolls-Royce Motor Cars Dealers

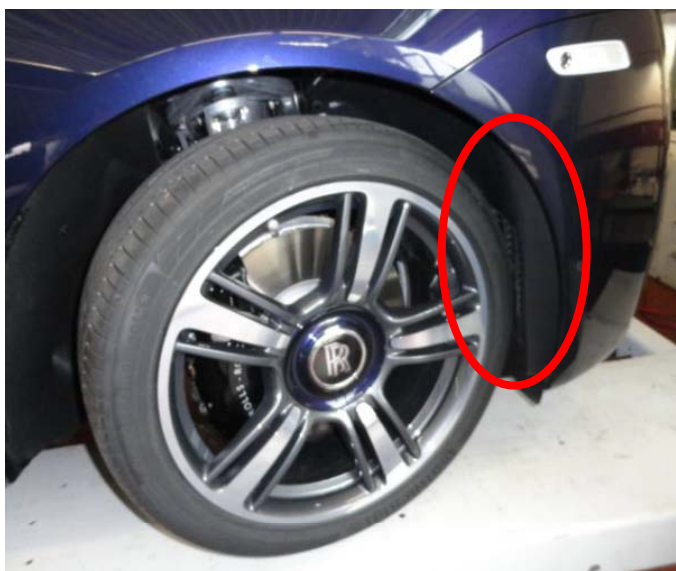
A small number of new Rolls-Royce Ghosts and Wraiths will require the below check to be completed due to a noise being caused by the front wheel of the car rubbing against the front wheel arch liner.

1. Move the steering wheel from left to right with a second person checking for contact in the area highlighted in the image below

If there is no contact then no further action is required.

2. If contact is found, please remove both front 'front section' wheel arch liners to check for correct fitment of the Cooler Air Guides. Please refer to ISTA repair instruction no 51 71 038.

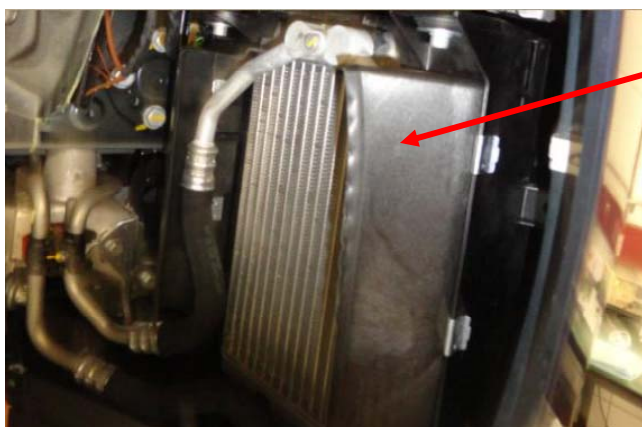
### Right side of vehicle:

The below image shows the incorrectly fitted part on the **right side** of the vehicle.

The front left inner cooler guide has been fitted to the right hand outer cooler guide position in error.

3. If the cool air guides are fitted incorrectly then:
  - a. The 'Outer Cooler Air Guide - right' needs to be removed and fitted to its correct position in the left hand inner
  - b. The part removed from the left side inner needs to be fitted to the right hand outer position
