SB-10056114-6520

Front Windshield Washer Jets Not Working

F56 (Cooper, Cooper S)

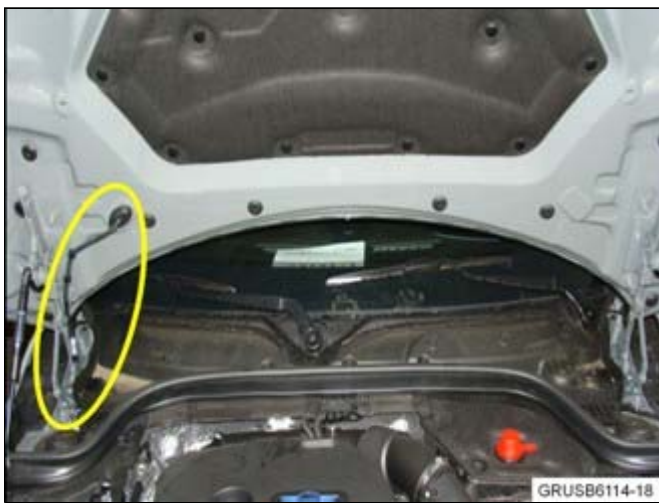
The windshield washer hose shown below is too short. This causes it to kink or disconnect.

1. Open the bonnet and locate the washer hose to be replaced near the passenger's side gas strut, attached to the bonnet.
