# SB-10056130-1121

## TECHNICAL SERVICE BULLETIN

TSB#: 14-012

Install USB Wi-Fi Dongle and inspect USB Dash Port Wiring

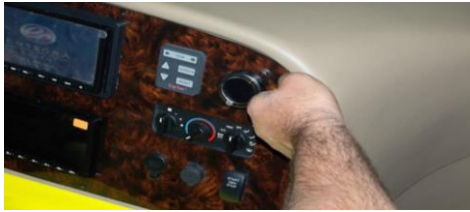
**CAUTION: Only a hand held screwdriver should be used to remove and re-install the screws on the inlay. Using a screw gun may cause damage to the inlay.**

Remove all the screws on the dash inlay using a **hand held** screwdriver.
