Program Bulletin

SB-10056151-3195

SUBJECT: Seat Mounted Side Impact Airbag Connector

**MODELS: 2014 Chevrolet Silverado 1500
 2014 GMC Sierra 1500**

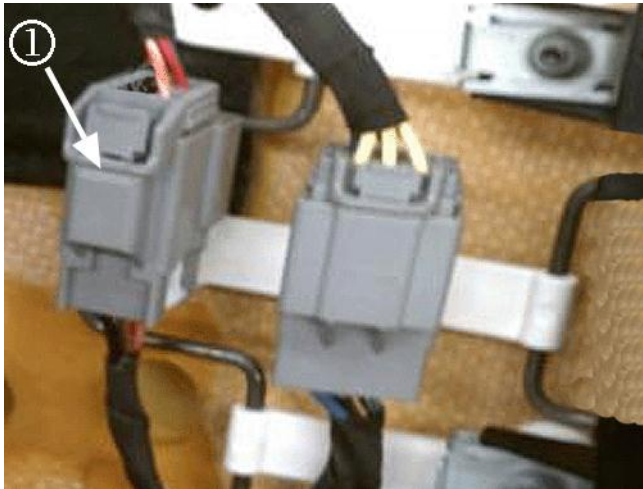
3957349

Note: Perform the procedure in this bulletin on BOTH the front driver and passenger seat. The SIAB connectors are located under the seat cushion, and the technician may find a single SIAB connector or may find a second connector with power seat circuits next to it. On the driver side it is a GREEN connector on the outboard side of the seat; on the passenger side it is a GREY connector on the inboard side of the seat.

1. Starting on the passenger seat, locate the inboard grey SIAB harness connector (1) on the underside of the seat cushion.
