Program Bulletin

SB-10056151-4930

SUBJECT: **Seat Mounted Side Impact Airbag Connector**

MODELS: **2014 Chevrolet Silverado 1500**
 2014 GMC Sierra 1500

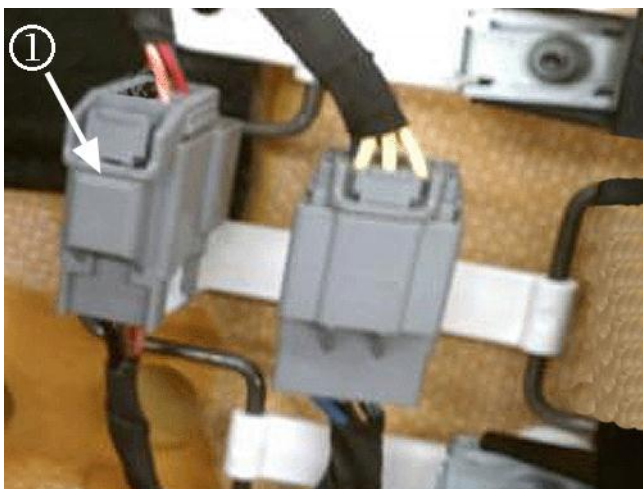
3957349

1. Starting on the passenger seat, locate the inboard grey SIAB harness connector (1) on the underside of the seat cushion.
