# Technical Journal

**Scraping noise, Front wheel hub conflict with brake disk, BCM-C003307  
C003007**

<b>REF NO:</b> TJ 25329	<b>ISSUING DEPARTMENT:</b> Technical Service	<b>CAR MARKET:</b> United States and Canada		
<b>PARTNER:</b> 3 US 7510 Volvo Cars North America		<b>ISSUE DATE:</b>		
<b>FUNC GROUP:</b> 7731	<b>FUNC DESC:</b> Hub, front	<b>YEAR</b> 2014	<b>MONTH</b> 08	<b>DAY</b> 06
<b>Page 1 of 7</b>

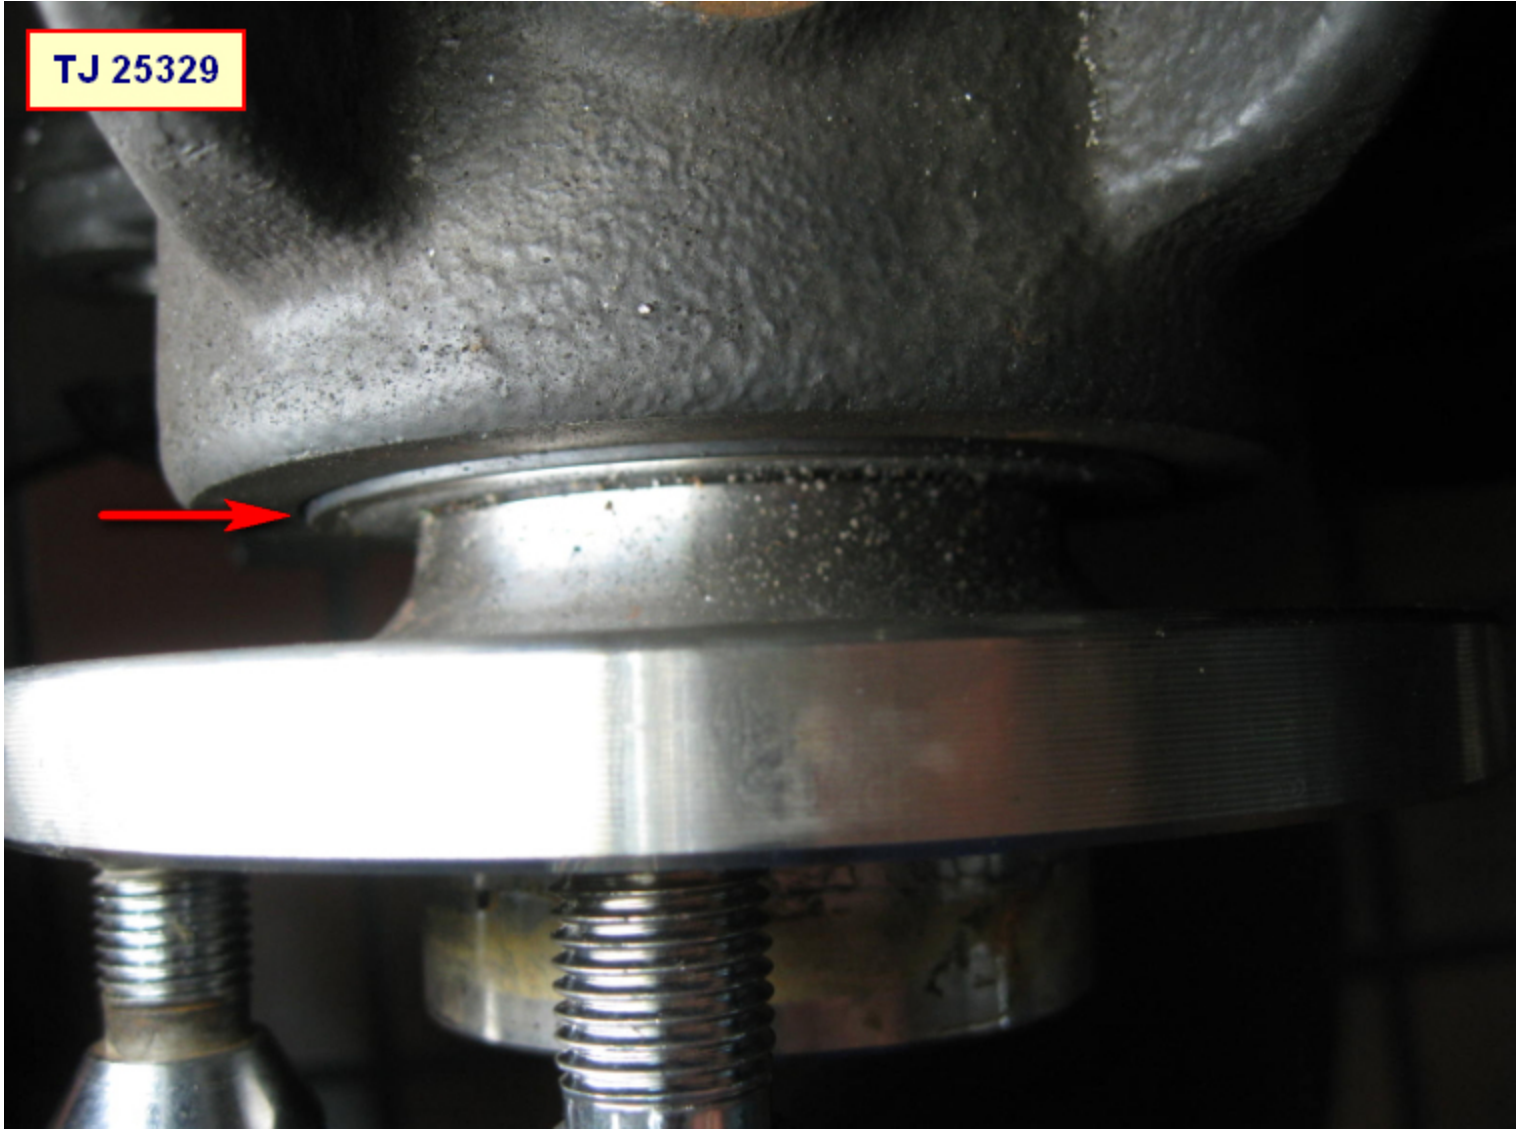
TJ 25329

The front wheel hub may become displaced in the steering knuckle (picture #1).

Analysis indicates that the wheel hub may be displaced in the steering knuckle if the vehicle is driven aggressively.

Check if the wheel hub is displaced in the steering knuckle, (refer to picture #1)

If confirmed, replace the wheel hub according to VIDA.

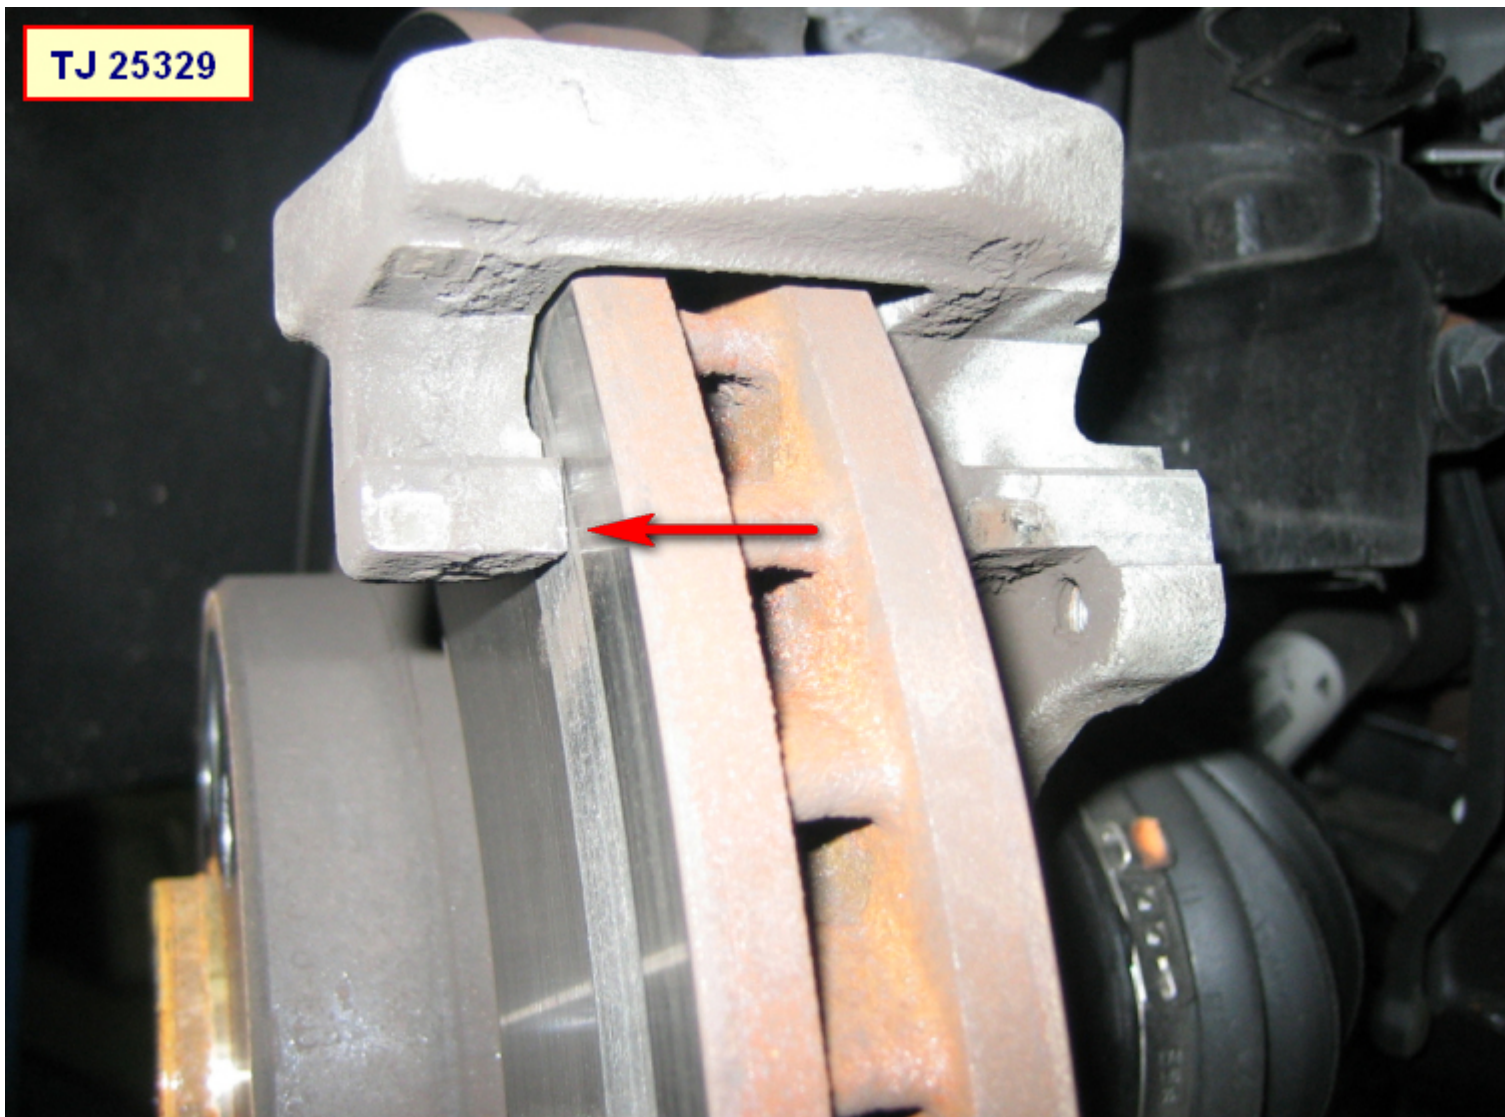
TJ 25329

- ABS warning message in DIM, with DTC BCM-C003307 or BCM-C003007.
- Grinding noise, when the front brake disk is rubbing against the brake caliper bracket, with scratch marks on the brake disk (picture #2).

Brake disk (if having scratch marks), Check VIDA Parts catalogue

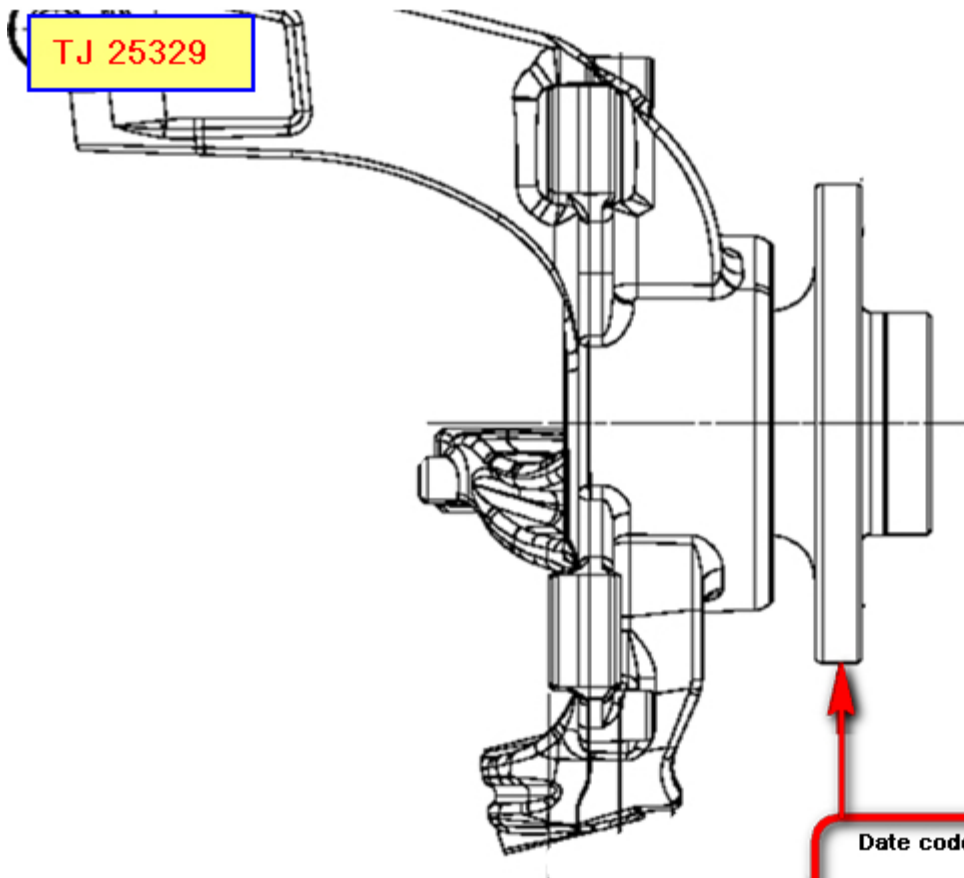
TJ 25329

Please include the date code that is engraved in the bearing flange (see picture #3), and if possible also attach a photo of the date code.

Date code

EXAMPLE:  
L 0001 144 05 AAB

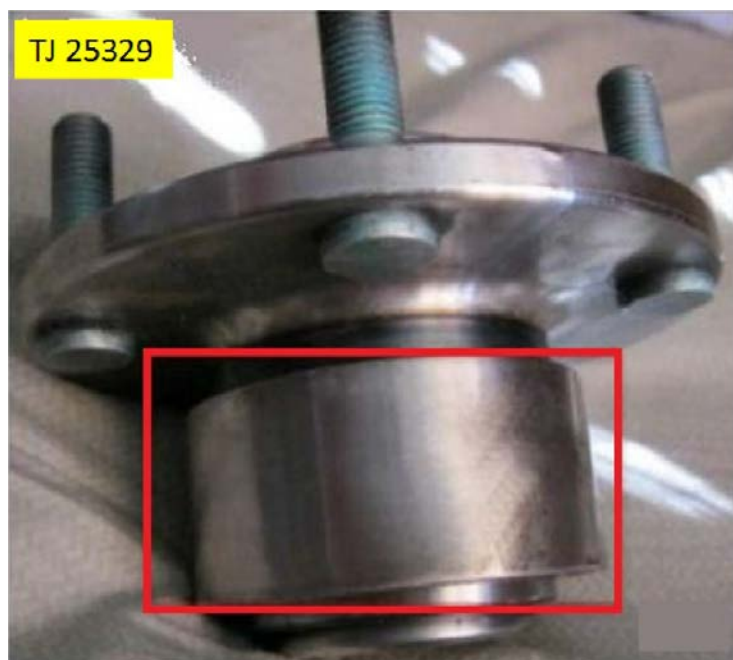
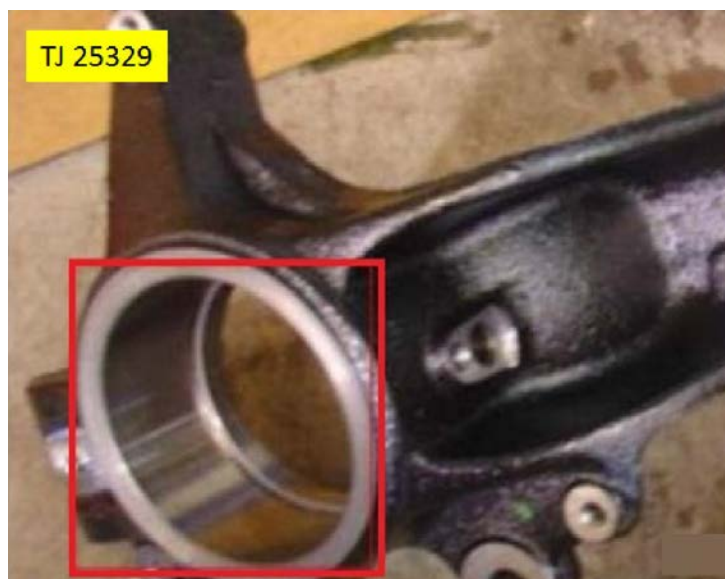
Surfaces to be cleaned using Volvo Cleaner, PN 1161721:

**Important!** Before pressing the new parts together, clean mating surfaces thoroughly on both knuckle and hub using Volvo cleaner in order to remove remaining traces of lubricants from the manufacturing process (See TJ Attachment 25329).
