Recall Bulletin

SB-10056213-2052

PRODUCT EMISSION RECALL

SUBJECT: Oxygen Sensor Fracture

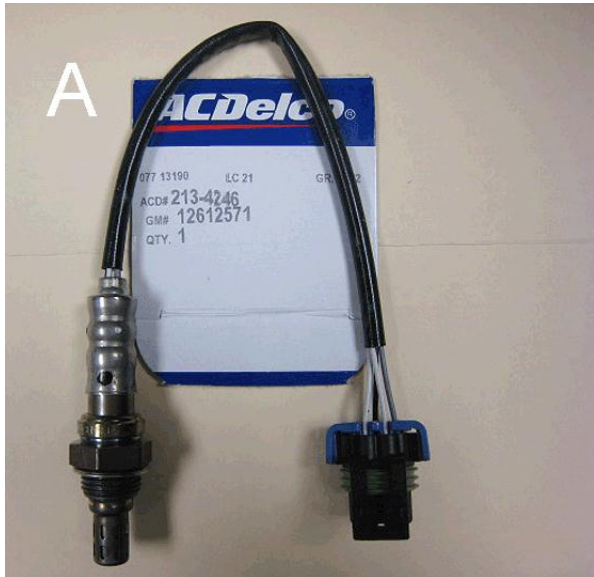
3961549

(A) 2011 through early 2013 OE production first design male connector. Replace the part with a second design part with a male connector, P/N 12637297. (B) 2011 through 2013 second design service part, P/N12637297. Do NOT replace this part unless the part has failed. If the part has failed, replace the part with the second design part with a male connector, P/N 12637297.

3. Determine if a first design (A) or second design (B) heated oxygen sensor is installed using a light and mirror.
 - If a second design (B), P/N 12637297, P/N 12656071 heated oxygen sensor is currently installed, no further action is required. Lower the vehicle. Refer to *Lifting and Jacking the Vehicle* in SI.
 - If a first design (A), P/N 12612571, heated oxygen sensor is in place, remove the sensor and replace it with a second design heated oxygen sensor. Refer to *Heated Oxygen Sensor Replacement –Bank 2 Sensor 2* in SI and *Heated Oxygen Sensor Replacement –Bank 1 Sensor 2* in SI.

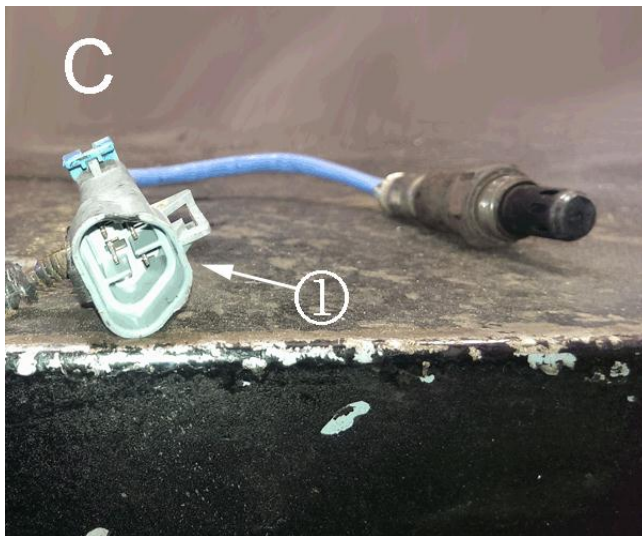
3961552

(C) This is the second design 2013 production sensor with the female plug (1). The sensor and plug change was made to indicate the new design. Do NOT replace this sensor, P/N12656071, unless the part has failed.
