Recall Bulletin

SB-10056213-2868

PRODUCT EMISSION RECALL

SUBJECT: Oxygen Sensor Fracture

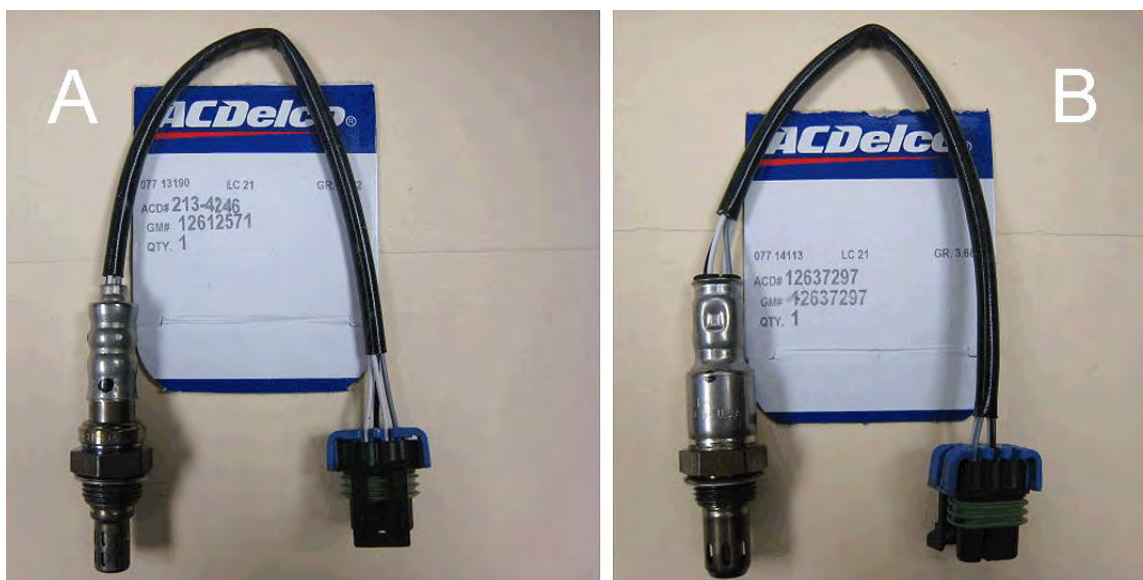
3961549

(A) 2011 through early 2013 OE production first design male connector. Replace the part with a second design part with a male connector, P/N 12637297. (B) 2011 through 2013 second design service part, P/N 12637297. Do NOT replace this part unless the part has failed. If the part has failed, replace the part with the second design part with a male connector, P/N 12637297.

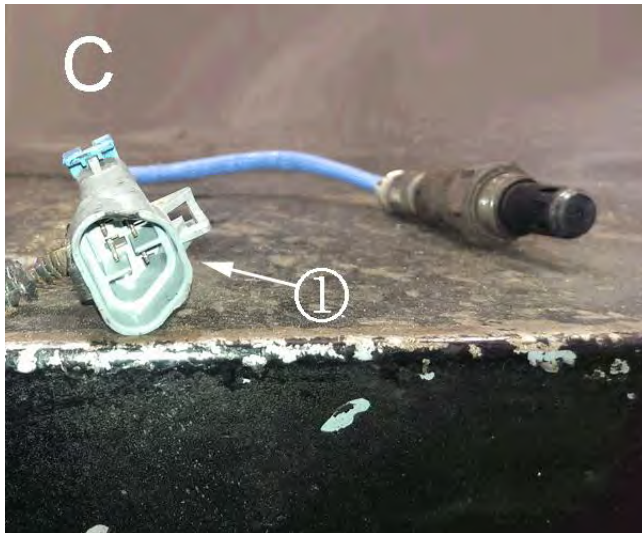
3961552

(C) This is the second design 2013 production sensor with the female plug (1). The sensor and plug change was made to indicate the new design. Do NOT replace this sensor, P/N12656071, unless the part has failed.
