Recall Bulletin

SB-10056213-4187

SUBJECT: Oxygen Sensor Fracture

MODELS: 2011-2013 Chevrolet Express
2011-2013 GMC Savana
Cutaway Equipped with Gasoline Engine

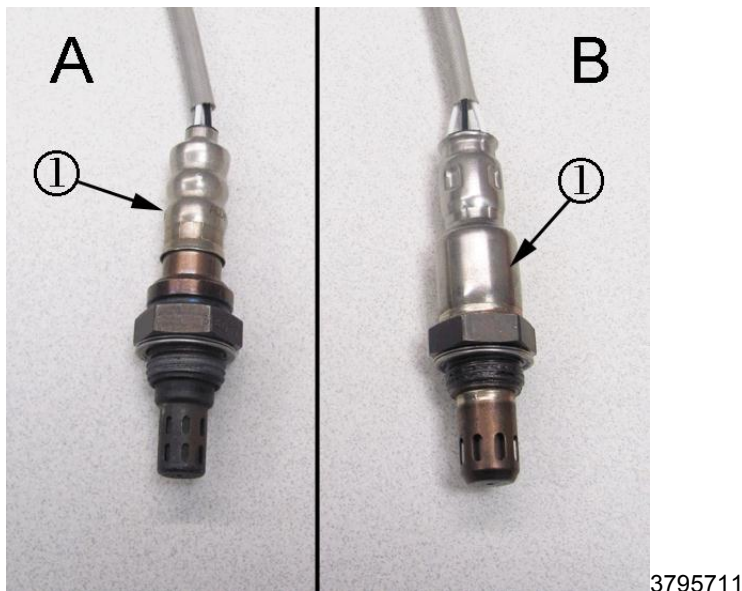
(A) First Design Heated Oxygen Sensor (B) Second Design Heated Oxygen Sensor (1) Location of Part Number

3. Determine if a first design (A) or second design (B) heated oxygen sensor is installed using a light and mirror.
 - If a second design (B), P/N 12637297, heated oxygen sensor is installed, no further action is required. Lower the vehicle. Refer to *Lifting and Jacking the Vehicle* in SI.
 - If a first design (A), P/N 12656071 or P/N 12612571, heated oxygen sensor is installed, remove the sensor and replace it with a second design heated oxygen sensor. Refer to *Heated Oxygen Sensor Replacement –Bank 2 Sensor 1* in SI and *Heated Oxygen Sensor Replacement –Bank 2 Sensor 2* in SI.
