Recall Bulletin

SB-10056213-7302

PRODUCT EMISSION RECALL

SUBJECT: Oxygen Sensor Fracture

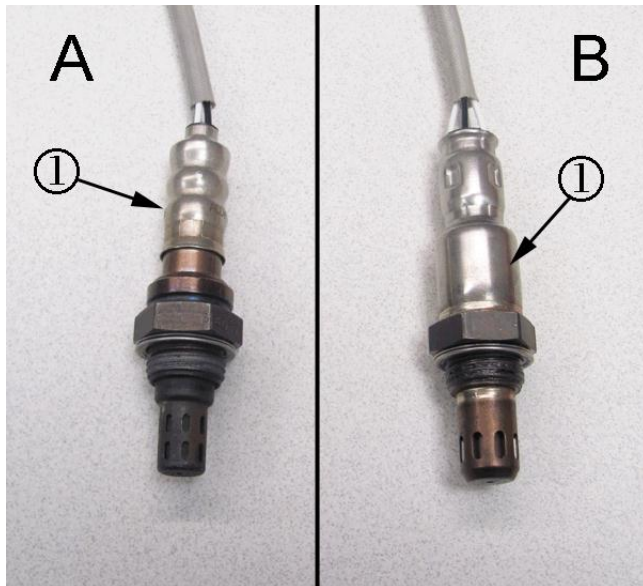
3795711

(A) First Design Heated Oxygen Sensor (B) Second Design Heated Oxygen Sensor (1) Location of Part Number

3. Determine if a first design (A) or second design (B) heated oxygen sensor is installed using a light and mirror.

- If a second design (B), P/N 12637297, heated oxygen sensor is installed, no further action is required. Lower the vehicle. Refer to *Lifting and Jacking the Vehicle* in SI.
 - If a first design (A), P/N 12656071 or P/N 12612571, heated oxygen sensor is installed, remove the sensor and replace it with a second design heated oxygen sensor. Refer to *Heated Oxygen Sensor Replacement –Bank 2 Sensor 2* in SI and *Heated Oxygen Sensor Replacement –Bank 1 Sensor 2* in SI.
4. After installing the new heated oxygen sensors, reprogram the ECM. Refer to *Engine Control Module Programming* in this bulletin.
