Program Bulletin

SB-10056214-9273

SUBJECT: Front Strut - Noise

MODELS: 2012-2013 Chevrolet Colorado
2013 Chevrolet Trailblazer

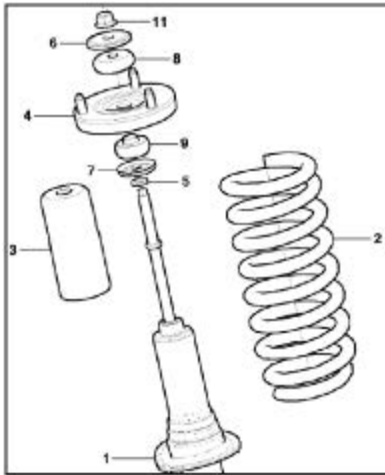
Figure 1

6. Refer to figure 1 - the lower bush (9) will be replaced as well as the spring seat insulator (not shown in figure 1). In addition, inspect the top mount bracket (4), cup washer (7), upper bush (8), and shocker absorber rod (1) for damage. Follow these guidelines to determine if these parts should be replaced:

4. Before removing the top mount bracket (refer figure 1, item 4), place alignment marks on the top mount bracket and spring using the outboard mounting bolt on the strut top bracket as a reference. Mark the bottom of the spring to shock absorber as well. These marks should all be aligned as shown in figure 2 and 3.

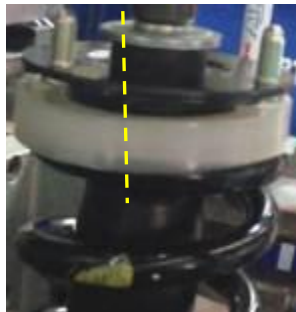
Figure 9

Phase II: Please refer to the affected VIN list (Trailblazer Build range: SORP – 25 Apr 2013 / 8,475 Units)

9. In case of Trailblazer front spring doesn't have yellow dot mark must be change spring improvement (with yellow). Install the top mount assembly into the rubber insulator taking care to align the paint marks, refer figure 9 & 10.
