Program Bulletin

SB-10056217-5338

SUBJECT: Tail Lamp Gasket Seal

MODELS: 2014 Chevrolet Impala

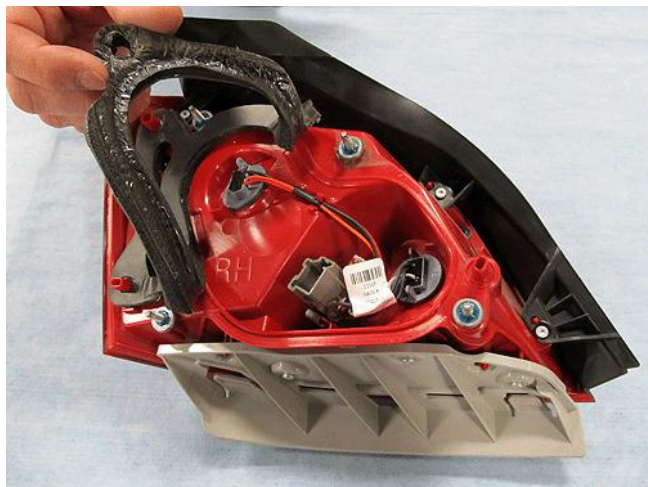
3649621

3. Place the tail lamp assembly on a soft work area to prevent damage to the outer lens area.
