Bulletin No.: PIP5198

Service Bulletin

Subject: Instrument Panel Cluster (IPC) Warning Lamps And/Or MIL Are Illuminated Diesel Exhaust Fluid (DEF) Message Displayed Various DTCs Set (Inspect Wiring Harnesses for Chafing)

Models: 2015 Chevrolet Silverado
2015 GMC Sierra
Equipped with 6.6L Duramax™ Diesel Engine RPO LML

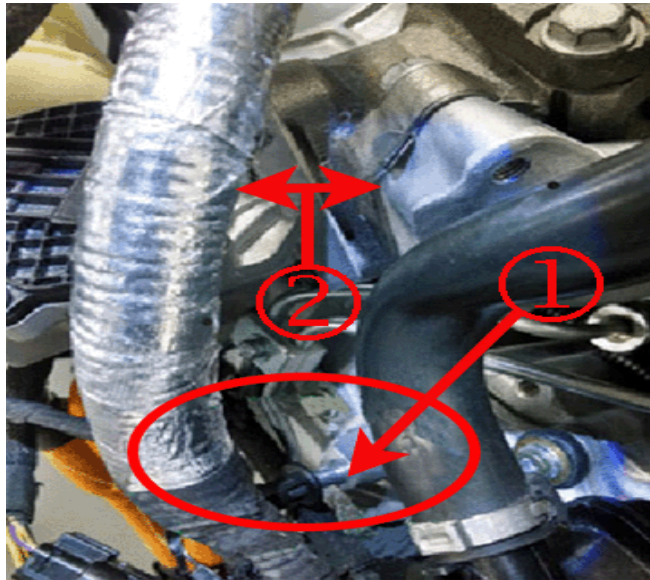
3825841

1. Wiring harness retainer fully seated onto the stud on the driver's side rocker cover.
2. Proper clearance between the harness and the EGR valve

It is critical that the wiring harness retainer is fully seated onto the stud on the driver's side rocker cover. This retainer is tied to the harness and is located underneath the charged air cooler (CAC) inlet pipe near the #4 fuel injector. Proper routing and securing of the harness ensures there is clearance between the harness and the EGR valve.

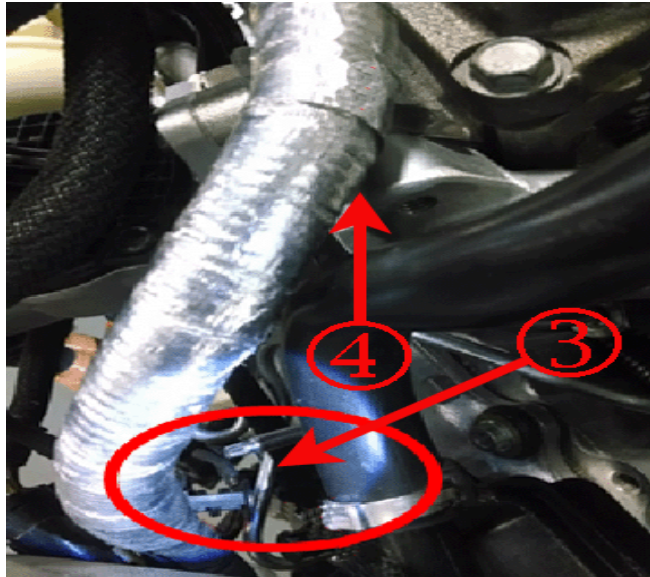
3825844

3. Wiring harness retainer NOT fully seated onto the stud on the driver's side rocker cover.
4. IMPROPER clearance between the harness and the EGR valve.
Bend the tab of the EGR gasket over to prevent a re-occurrence.
