Bulletin No.: P11280

Service Bulletin

Subject: Service Hybrid System Message, MIL or Loss of Propulsion with DTC P1ABE, P0A7E or P0C32 Set

Models: 2009-2013 Cadillac Escalade
2009-2013 Chevrolet Silverado
2008-2013 Chevrolet Tahoe
2009-2013 GMC Sierra
2008-2013 GMC Yukon
Equipped with RPO M99

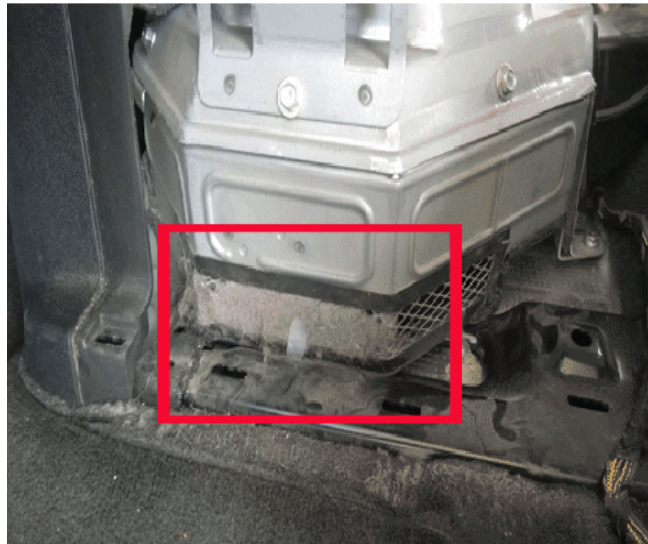
3951923

Some customers may comment that the malfunction indicator lamp (MIL) is illuminated, Service Hybrid System message displayed on driver information center (DIC) and/or loss of propulsion when the vehicle speed is less than 5 km/h (3 mph) with DTCs P1ABE, P0A7E and P0C32 set.

If obstructions or blockages are found as shown in illustration above, remove as necessary. Complete Service Information (SI) for the associated Diagnostic Trouble Code (DTC).
