**SB-10056246-2845**

Bulletin No.: P1281

## Service Bulletin

**Subject:** Sliding Door Does Not Stay Open While Vehicle is on a Downslope and/or Sliding Door Closes too Easily

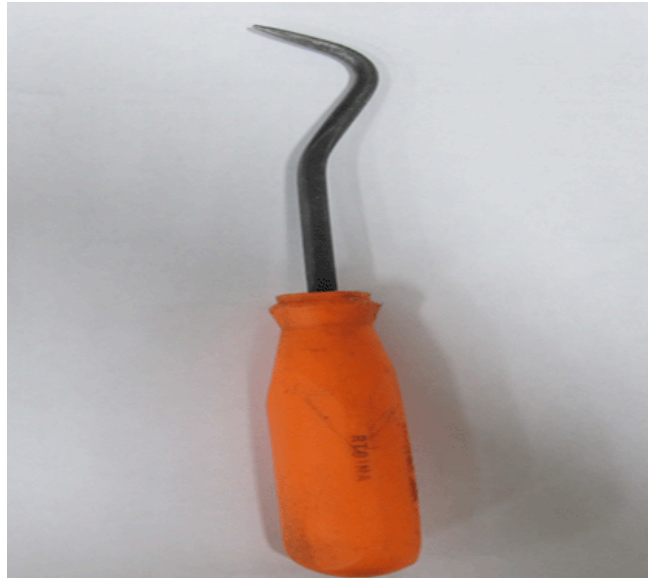
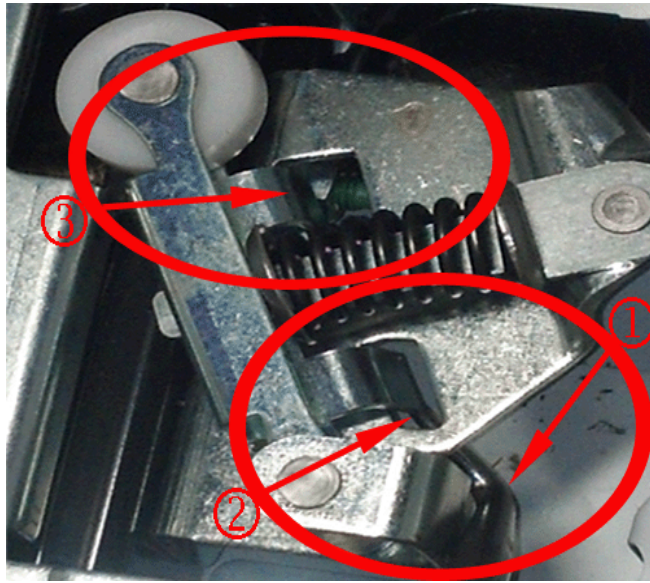
This condition may be due to the position of the roller arm not holding the sliding door in the open position.

2. Use a pick tool and place under the base plate of the checker (1) and hook the tab (2) while bending inboard. Ensure the tab that is closest to the roller is now touching the trim edge (3) of the window with no gap as shown in the illustrations above.
