# SB-10056293-5903

## NEMA 14-50 Wall Adapter Upgrade, U.S.

<b>Classification</b>	Recall Bulletin	<b>Section/Group</b>	50 - External Charging Connectors	<b>Country/Region</b>	United States
<b>Year</b>	2012 - 2014	<b>Model</b>	Model S	<b>Version</b>	All

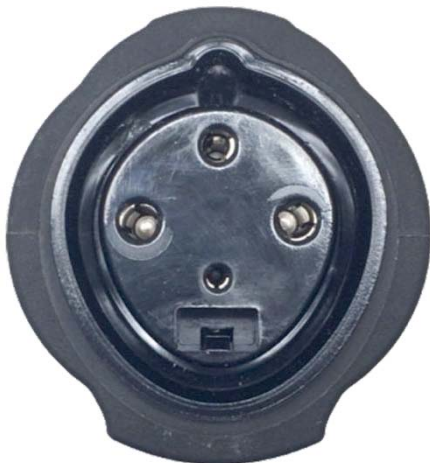
Factors such as corrosion, physical damage to receptacles, or the inappropriate wiring or installation of electrical outlets might cause higher than normal electrical resistance when charging with the Universal Mobile Connector (UMC) NEMA 14-50 adapter. When charging, higher-than-normal electrical resistance might cause excessive heating of the adapter.

Tesla Motors is recalling all black NEMA 14-50 adapters, which were included with all Model S vehicles that were delivered between September 15, 2012 and January 10, 2014. The new adapters with gray faces are not part of this recall.

Figure 1 (Old adapter with black faceplate)

Ensure that the vehicle has firmware version 5.8.4 or later. If the customer has not yet received the upgraded adapter by mail, provide the customer with an upgraded adapter if one is available in stock.

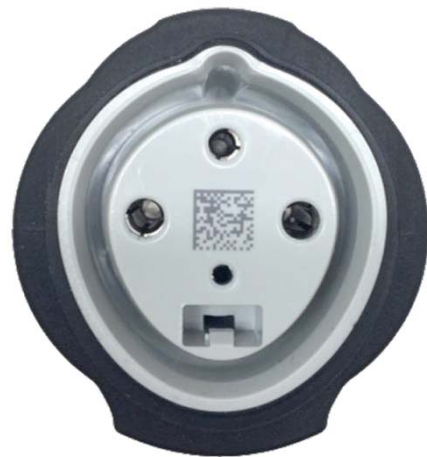
**NOTE:** Although the new adapter was originally designed with a thermal fuse to prevent overheating, the production version has strengthened materials and welds that prove to be more effective than the original design.

Figure 2 (New adapter with gray faceplate)

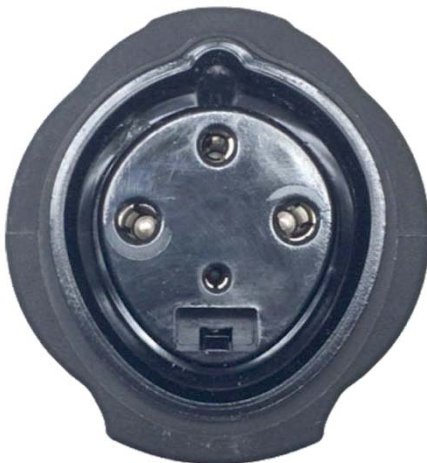
Factors such as corrosion, physical damage to receptacles, or the inappropriate wiring or installation of electrical outlets might cause higher than normal electrical resistance when charging with the Universal Mobile Connector (UMC) NEMA 14-50 adapter. When charging, higher-than-normal electrical resistance might cause excessive heating of the adapter.

Tesla Motors is proactively replacing all black NEMA 14-50 adapters, which were included with all Model S vehicles that were delivered between September 15, 2012 and January 10, 2014.

Figure 1 (Old adapter with black faceplate)

Ensure that the vehicle has firmware version 5.8.4 or later. If the customer has not yet received the upgraded adapter by mail, provide the customer with an upgraded adapter if one is available in stock.

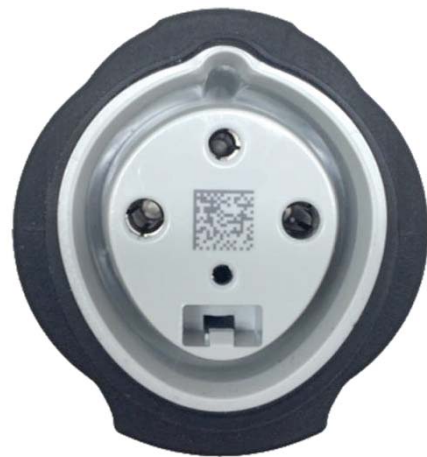
**NOTE:** Although the new adapter was originally designed with a thermal fuse to prevent overheating, the production version has strengthened materials and welds that prove to be more effective than the original design.

Figure 2 (New adapter with gray faceplate)
