SB-10056336-1366

TO: All Mazda Dealership General Managers, Service Managers, and Parts Managers
DATE: August 2014
SUBJECT: 2003-2004 Mazda6 and 2004 RX-8 Passenger Air Bag Safety Recall 7714F

2003-2004 MAZDA6 AND 2004 RX-8 - PASSENGER AIR BAG SAFETY RECALL 7714F

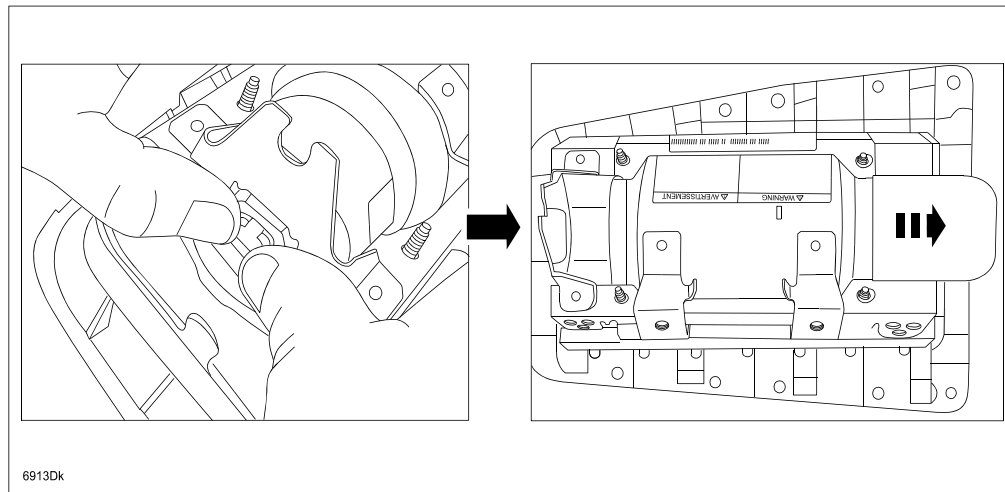
4. Push the inflator end with fingers, then remove it by sliding it in the direction shown below.

IMPORTANT: Return the removed inflator in the same carton in which the new part was received. Carefully follow the packing and shipping instructions included in the carton.

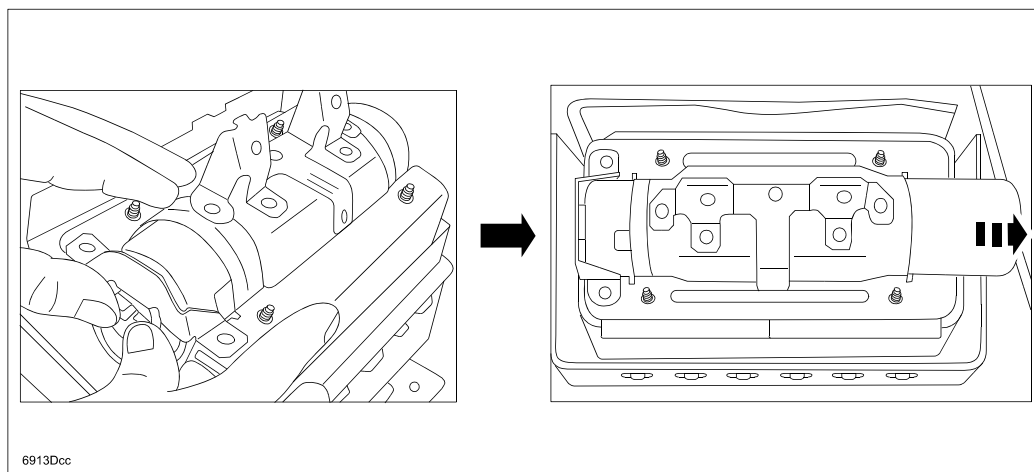
6. Push the inflator end with fingers, then remove it by sliding it in the direction shown below.

IMPORTANT: Return the removed inflator in the same carton in which the new part was received. Carefully follow the packing and shipping instructions included in the carton.
