**Wire Harness Corrosion in Driver's Footwell
Causing No-Start Situation**

Binder - Advanced Technical Information

Models: **Cayenne/S/GTS/Turbo (2nd Generation)**

Model Year: **2003-2010**

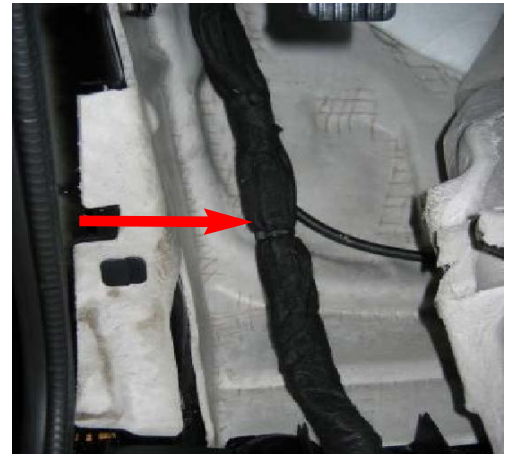
Figure 1 - Main Wiring Harness

- Remove battery cover according to WM 72161901.
- Remove and reinstall B pillar trim according to WM 70671900.
- Remove and reinstall inner door sill trim according to WM 68051900.
- Pull back carpet trim on driver's footwell and locate main wiring harness (Figure 1).

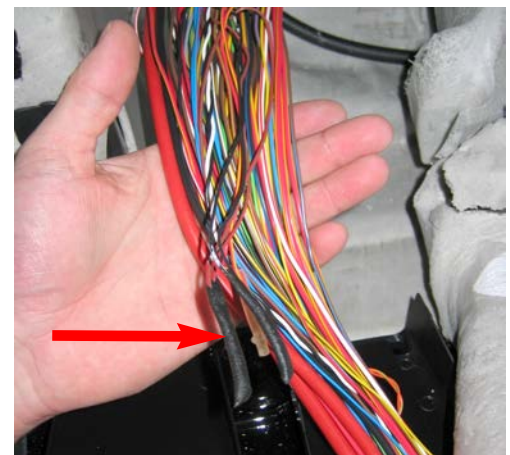
Figure 2 - Revealed Wiring Harness

- Strip back protective covering to reveal wiring (Figure 2).

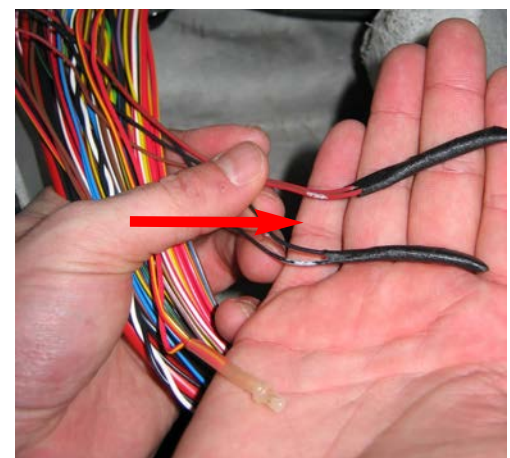
Figure 3 - Splices in Harness

- Locate the two unsealed splices in wiring harness (Figure 3). Do not modify the one splice which is already sealed in the clear protective cover, unless it is clear that these wires are corroded.
