# Spartan Motors Chassis, Inc.

SERVICE BULLETIN

RSB14-310-004

**SUBJECT:** High pressure fuel fitting wear.

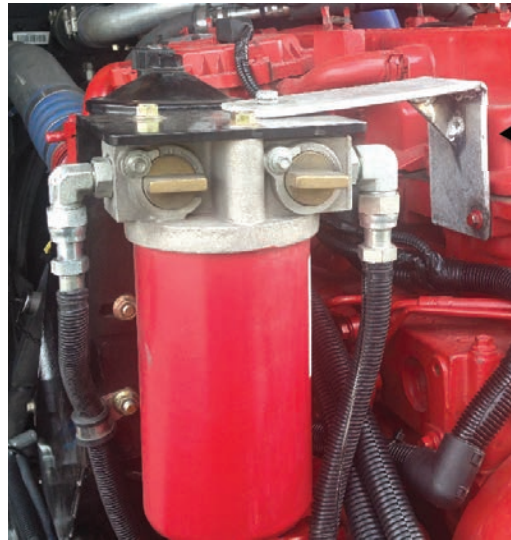
**FIG. 2-1**

If bracket is installed,  
remove and discard.

1. Inspect for bracket between power steering reservoir/fuel filter bracket and engine. If bracket is present between the engine and support brackets, as shown below remove it completely. Properly dispose of bracket and hardware. Refer to FIG. 2-1.
