Document ID: IK1400033

Major System: REAR AXLE

SB-10056352-3070

Title: Torque change for 5/8 inch rear axle shaft flange mounting stud with cone locks and flat washer type hardware.

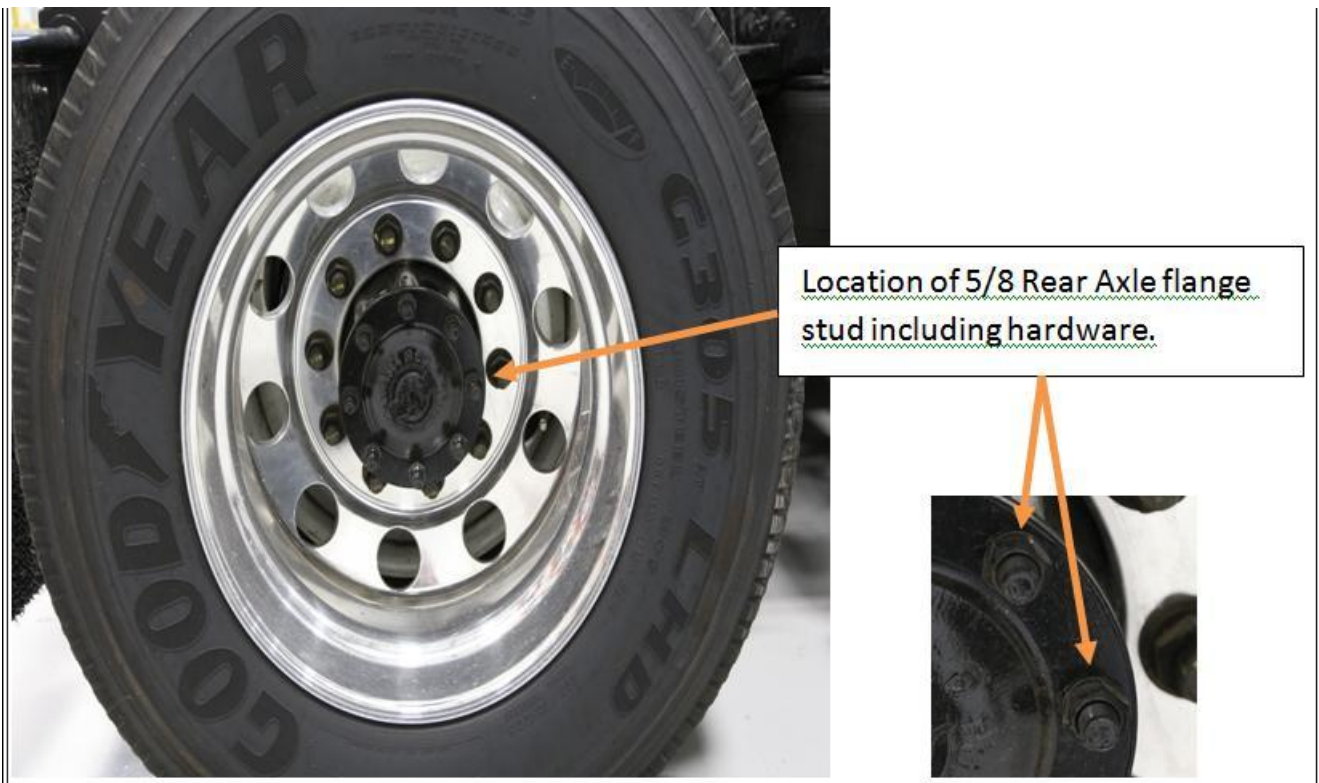
Figure 1 (Inspection)

- 5/8 inch rear axle flange stud missing or loose.
- Rear axle flange leaking due to missing or loose stud hardware.

- 1) Inspect for missing or loose 5/8 axles shaft hardware (Figure 1).
- 2) If any loose or missing hardware is found, replace missing 5/8 rear axle flange hardware
- 3) Re-torque all 5/8 rear axle flange hardware to 145 - 175 ft*lbs using correct torque sequence (Figure 2)
