Recall Bulletin

SB-10056365-5257

SUBJECT: Improperly Crimped Accelerator Pedal Position Electrical Terminals

MODELS: 2014 Cadillac ATS

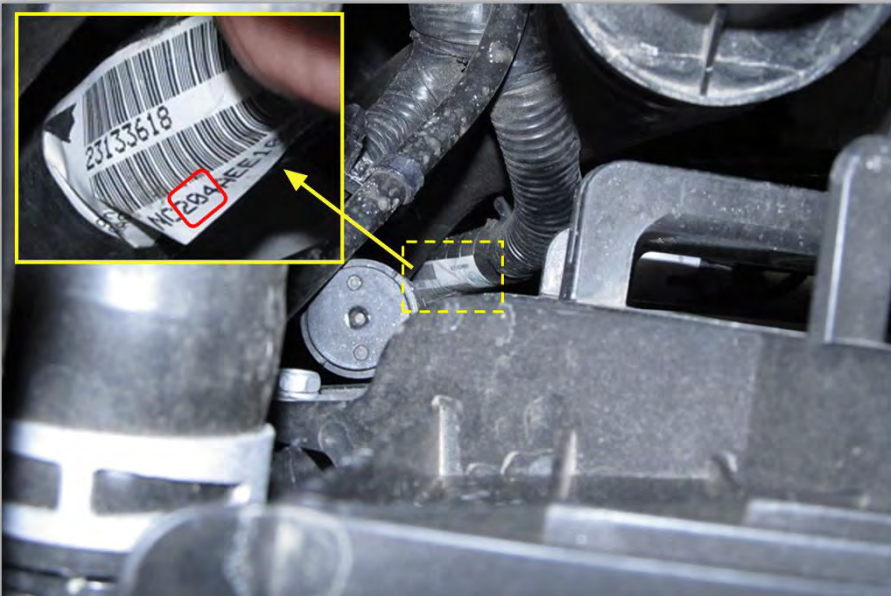
3942442

Tag and Date Code as Viewed from Top on a Four Cylinder Vehicle

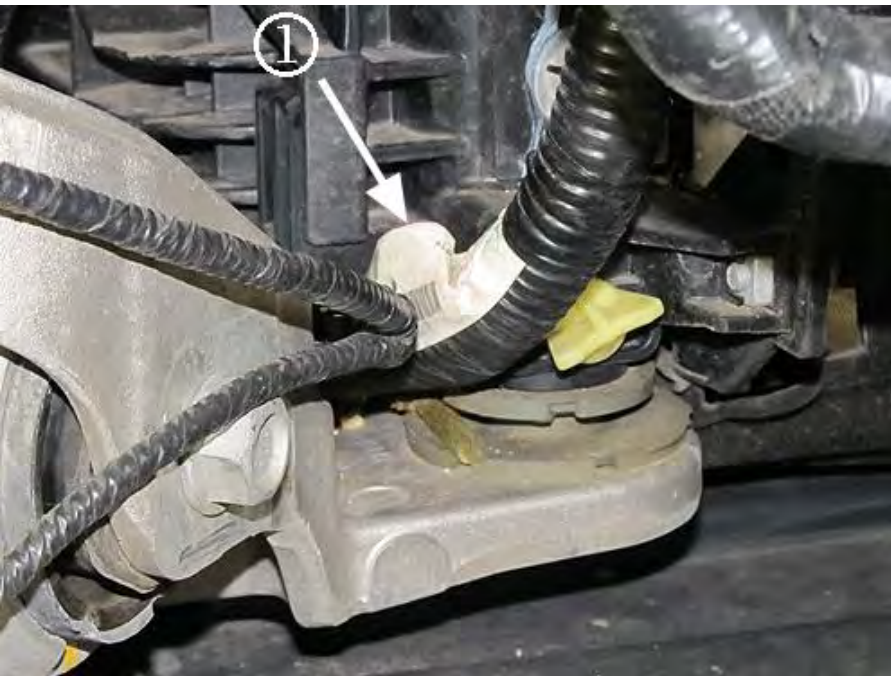
3942440

Tag (1) as Viewed from Bottom on a Six Cylinder Vehicle

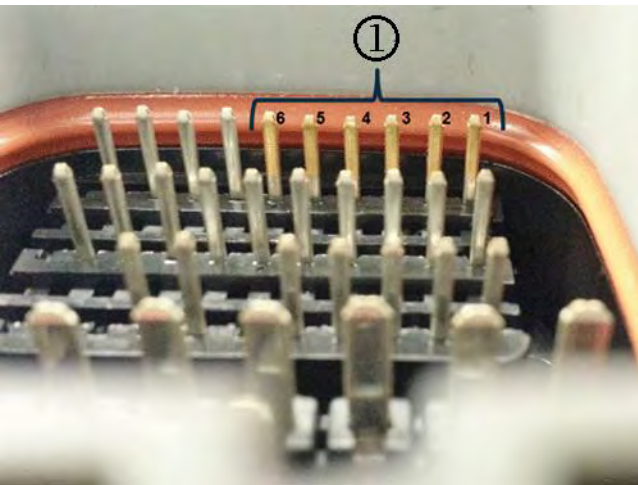
Caution: The Accelerator Pedal Position (APP) sensor circuits are cavities 1 through 6 within the X150 connector. All six terminals for APP must be gold plated.

7. Disconnect the connector and inspect the engine-side (male) terminals, 1 through 6 (1). As shown in the graphic above, the six terminals are gold and the surrounding terminals are tin.
 - If the Julian date code is **outside** the 182 – 187 range AND all six terminals are gold plated, no further action is required. Proceed to *Reassembly Procedure* below.

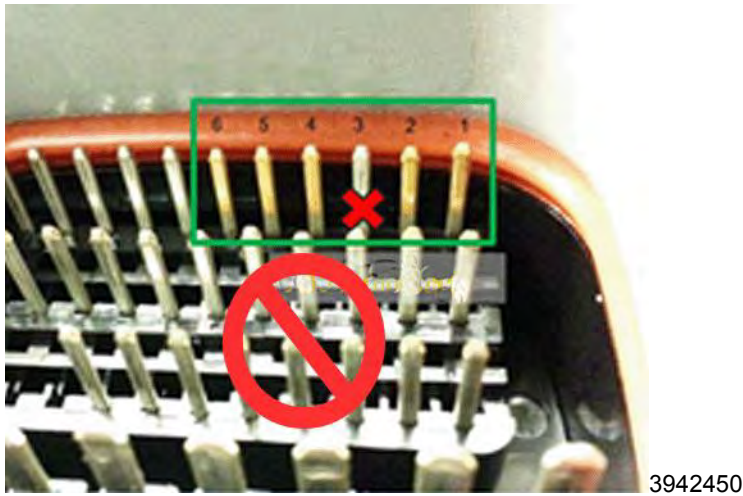
3942450

- If the Julian date code is **outside** the 182 – 187 range AND any tin plated terminals are found (like example shown in third terminal above), proceed to *Terminated Lead Replacement Procedure* below.
- If the Julian date code is **within** the 182 – 187 range AND all six terminals are gold plated, proceed to *Solder Terminal Crimps Repair Procedure* below.
- If the Julian date code is **within** the 182 – 187 range AND any tin plated terminals are found, solder the gold terminals and replace any tin terminals with a gold terminated lead. Follow first the *Terminated Lead* procedure, then the *Solder Terminal Crip* procedure below.
