**SB-10056369-9230**

Bulletin No.: P11097A

# Service Bulletin

**Subject:** Intermittent Service Power Steering Message on DIC, DTC C0544 Set

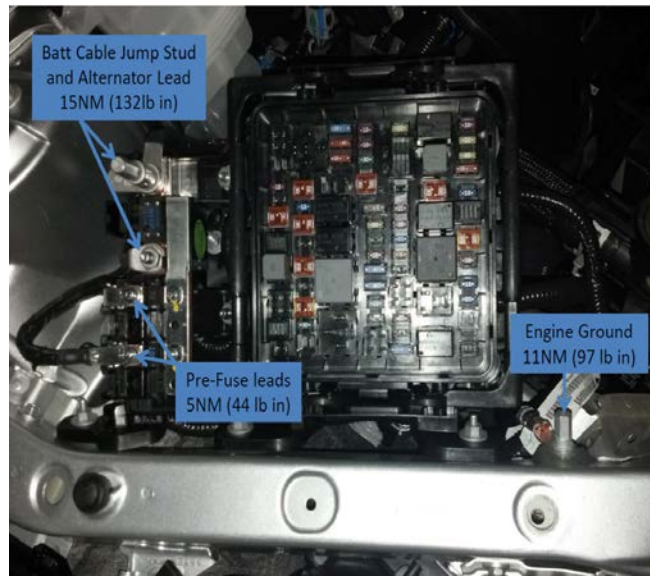
3648055

If no DTCs are present, the issue may be caused by a momentary loss of power or ground in the power steering gear circuits. Use the following steps to correct the condition.

1. Inspect the underhood fuse block power and ground connections for proper torque as identified in the above photo.
2. Inspect the X1, X2 and X3 connectors at the Power Steering Control Module (steering gear) for damaged or spread terminals on the vehicle harness or on the Power Steering Control Module. Ensure the connectors are completely seated.

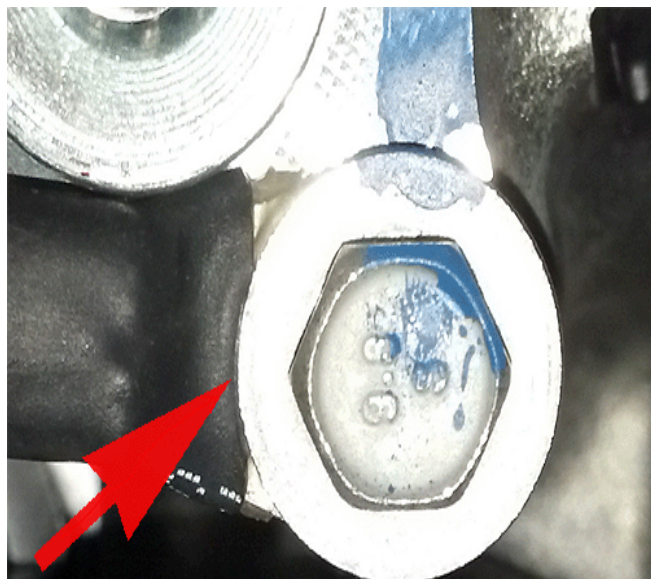
3575838

Look for either excess shrink wrap or glue under the eyelet. Inspect for adhesive that has seeped out onto the eyelet during the heating of the shrink tube, or the shrink tube itself extending into the eyelet area.

**Important:** It is not an adequate check to simply try to wiggle the ground wire to check for looseness. The ground must be removed and checked for these items, cleaned and reinstalled.

4. Carefully trim the heat shrink tube if needed, clean adhesive from the eyelet (sand off), reinstall and torque.
