Bulletin No.: 14412  
Date: August 2014

## SB-10056370-9223

**SUBJECT:** Left Rocker Panel Split below B-Pillar

**MODELS:** 2014 GMC Acadia

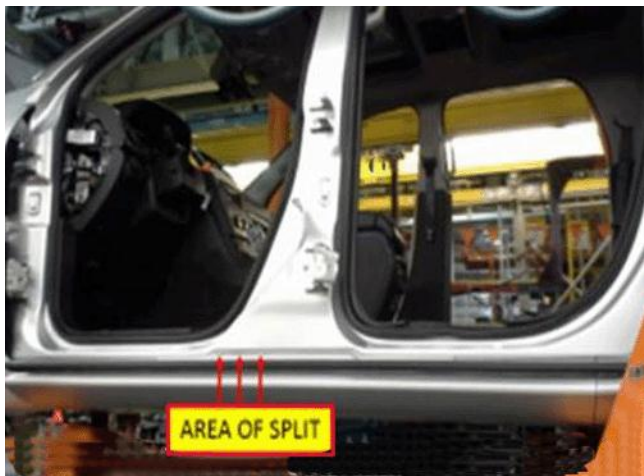
3961885

Use the following steps to inspect and repair the left rocker panel for a split in the metal. This condition is at the base of the B pillar just above the rocker panel molding.
