IB14-X-001

DARK COOLANT – CORROSION INHIBITOR ADDITIVES

- All Isuzu N-Series
Equipped with RPO Codes IB2, IB4 or I0H

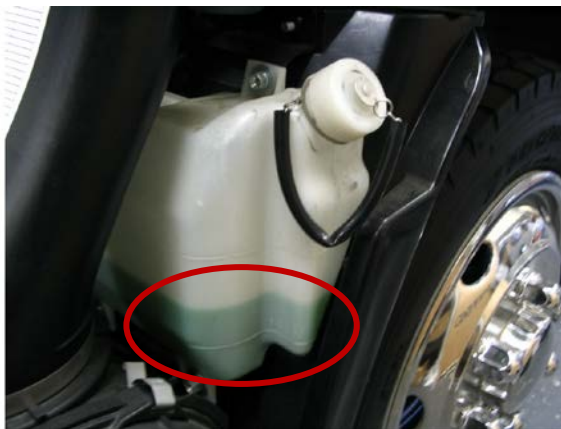
Figure 1 – Without Corrosion Inhibitor

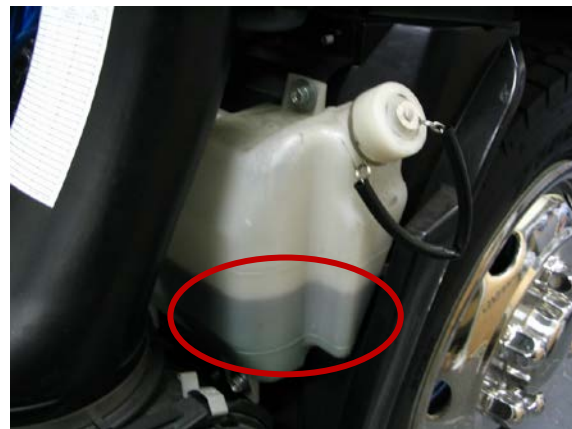
In an effort for continuous improvement and customer satisfaction, Isuzu would like to ensure dealers are aware of a corrosion inhibitor which changes the coolant to a dark color (See Figures 1 and 2). This corrosion inhibitor is added at the port to both the radiator and the surge tank prior to delivery when a vehicle is ordered with RPO Codes IB2, IB4 or I0H.

Technicians may perceive this to be engine oil or another contaminant in the coolant. Technicians should check the vehicle build for RPO Codes IB2, IB4 or I0H before continuing diagnosis. If the vehicle is equipped with these RPO Codes, the condition is normal and no action is necessary, unless other symptoms suggest further diagnosis. Please see the appropriate service manual for further details.

Figure 2 – With Corrosion Inhibitor

A vehicle without one of these RPO Codes can have this condition, as corrosion inhibitors are also commercially available. Be sure to ask customers if they are using a corrosion inhibitor before diagnosing or servicing a vehicle with dark colored coolant.
