BULLETIN NUMBER:
SB13-04-S001A

SAFETY RECALL 12V-406

DRIVER DOOR SWITCH SHORT CIRCUIT

- 2006-2007MY Isuzu Ascender Vehicles

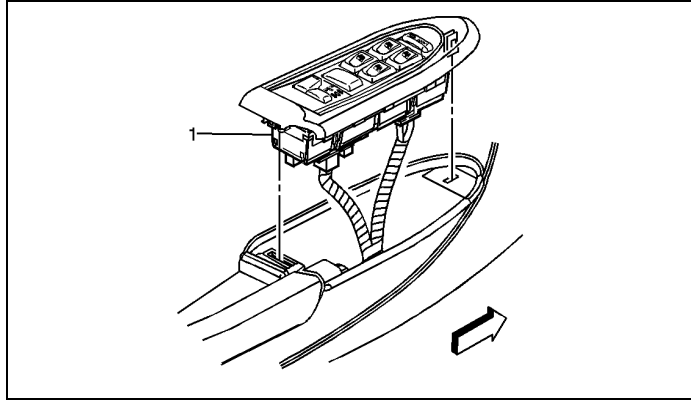
Figure 1 – Driver Side Door Lock & Side Window Switch

If fluid enters the driver's door module, it may cause corrosion that could result in a short in the circuit board. A short may cause the power door lock and power window switches to function intermittently or become inoperative. In rare cases, a short may cause overheating, which could melt components of the door module, producing odor, smoke, or a fire.

1. Remove the driver side door lock and side window switch. Refer to *Door Lock and Side Window Switch Replacement - Driver Side* in the service manual.

2. Determine the part number on the driver side door lock and side window switch. The part number is on the side of the switch on the label.
 - a) If the part number on the switch is listed in the parts table, no repair is required. Re-install the driver side door lock and side window switch. Refer to *Door Lock and Side Window Switch Replacement – Driver Side* in the service manual, and then proceed to Step 3, “Applying the Campaign Label”.

- b) If the part number on the switch is NOT listed on the table above, replace the driver side door lock and side window switch. Refer to *Door Lock and Side Window Switch Replacement – Driver Side* in the service manual.
