# Technical Bulletin

## SB-10056394-3328

Model(s)	Year	Eng. Code	Trans. Code	VIN Range From	VIN Range To
Tiguan	2013-2014	2.0L (CCTA)	All	All	All

MIL ON, DTC P0236 Turbocharger Boost Sensor (A) Circ. Range Performance Stored in ECM Fault Memory

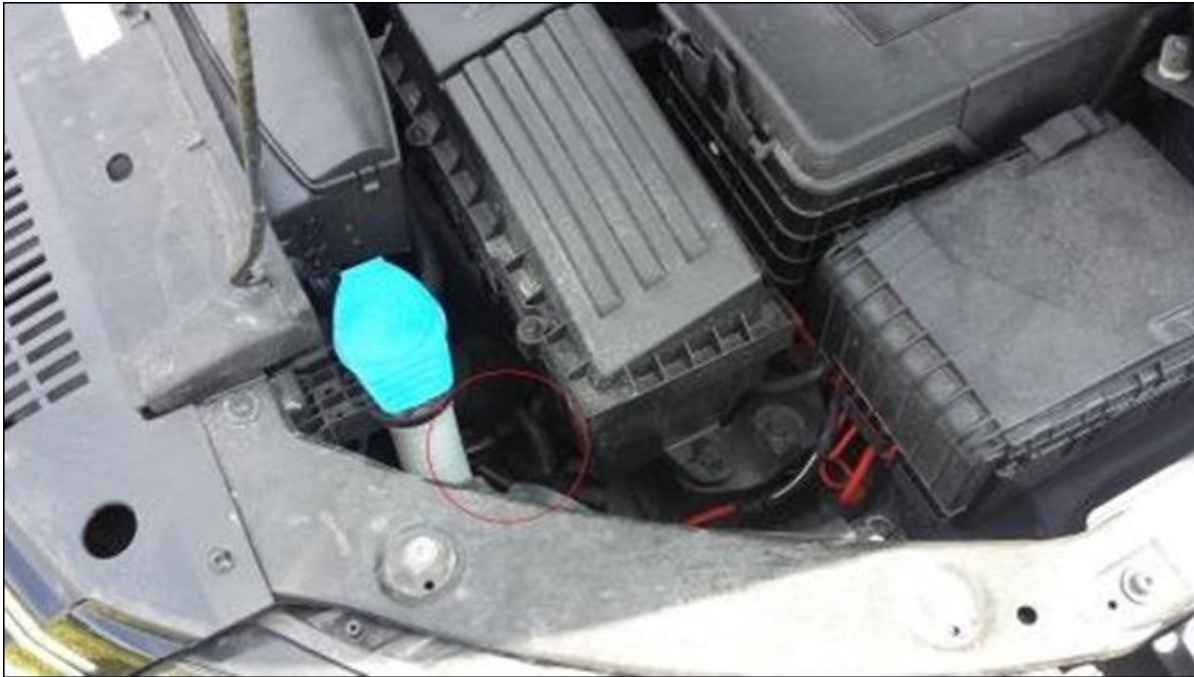
Figure 1

- Locate the T14 connector in front of the air box, behind the left front headlight. Wiring repair to be performed on the engine harness side (male pin side) (figure 1).
