TECHNICAL BULLETIN JTB00301NAS1 26 MAR 2014

SB-10056413-5208

SECTION: 310-00 Fuel Gauge Operation **AFFECTED VEHICLE RANGE:** XK Range (X150) Model Year: 2010-2012 VIN: B32753-B47682 XF (X250) Engine: V8 5.0L Petrol Model Year: 2010-2012 V8 S/C 5.0L Petrol VIN: R47154-S23314 MARKETS: NAS **CONDITION SUMMARY:** Situation: The fuel gauge may experience one or more of the following issues: Fuel gauge inoperative; • Fuel gauge not showing more than 1/2 full; Fuel gauge fluctuates; and/or • Fuel gauge switches on/off intermittently. Cause: These issues may be caused by: • Backed-out pins in any of the following areas: - internal to the fuel tank (sender wiring); - fuel pump module; and/or - fuel tank flange assembly. • Fretting corrosion across the fuel sender harness pins inside the fuel tank (black connectors). NOTE: Refer to TOPIx Workshop Manual, Section 310-01: Fuel Tank and Lines Diagnosis and Testing; if a harness or fuel sender fault cannot be identified, follow the Service Instruction outlined below. NOTE: Please advise the customer, if possible, to bring the vehicle in with the fuel tank level below 1/4 full.

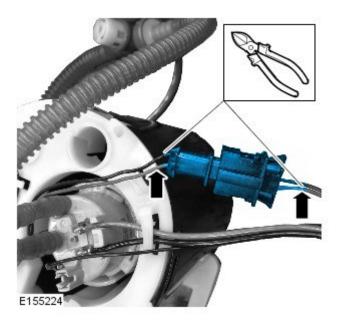
E155408

Identify a black two-pin connector to be removed.

• Cut wiring as close to the connector as possible.

7. CAUTION: Make sure the wiring is cut as close to the connector as possible.
