TECHNICAL BULLETIN  
K192NAS1  
07 APR 2014

**SB-10056416-2269**

Service Action: Folding Top Enhancement Program

**F-TYPE (X152)**

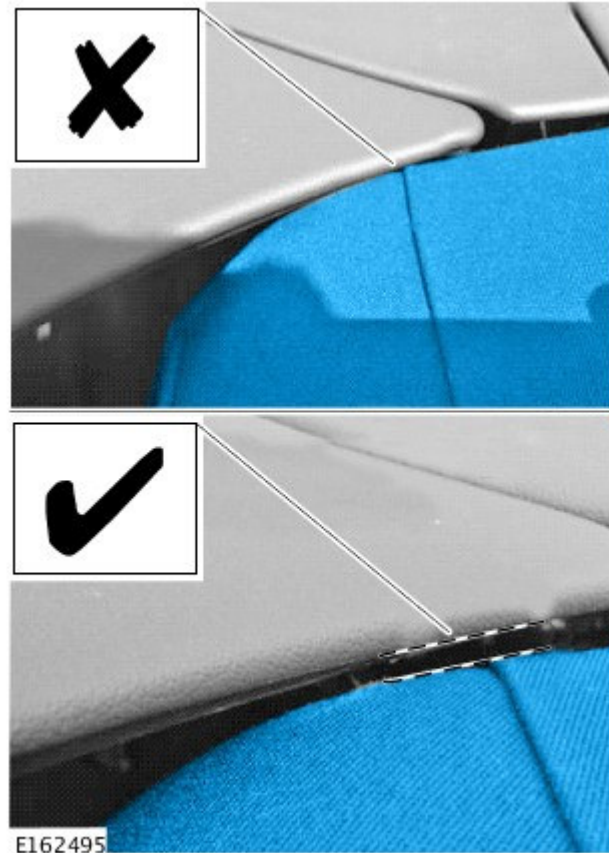
1. With the folding top in the open position, assess the gap from the folding top to the secondary folding top flap. It should be at least 2mm (vertically) and even across the vehicle.
  - If the gap is OK (no contact present), continue to Folding Top Harness - Check/Adjust or Replace.
  - If the gap is not OK (contact present), continue to step 2.

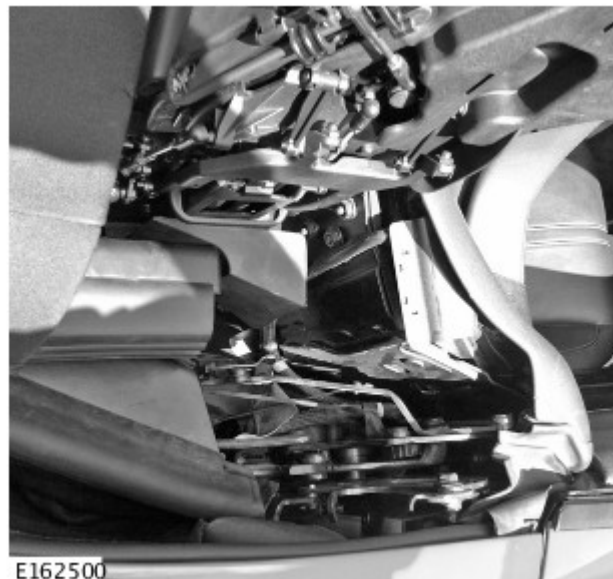
E162500

6. With the folding top in the open position, operate the folding top switch until the secondary folding top flaps are in the raised position.
  - Check for wiring harness damage and harness position under both of the folding top flaps.

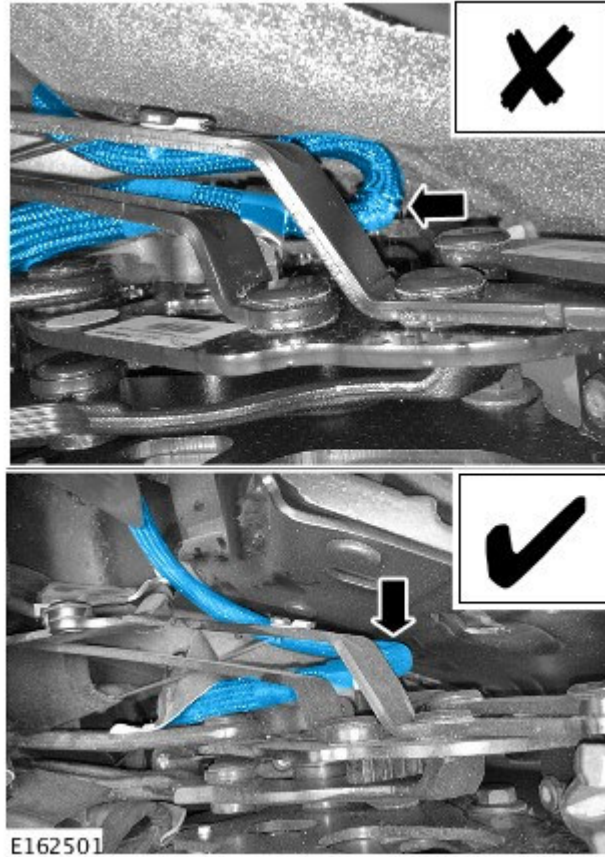
**NOTE: Right-hand harness shown.**

Inspect the right-hand harness; make sure right-hand harness is looped below the link and pulled down rather than trapped horizontally against the foam.

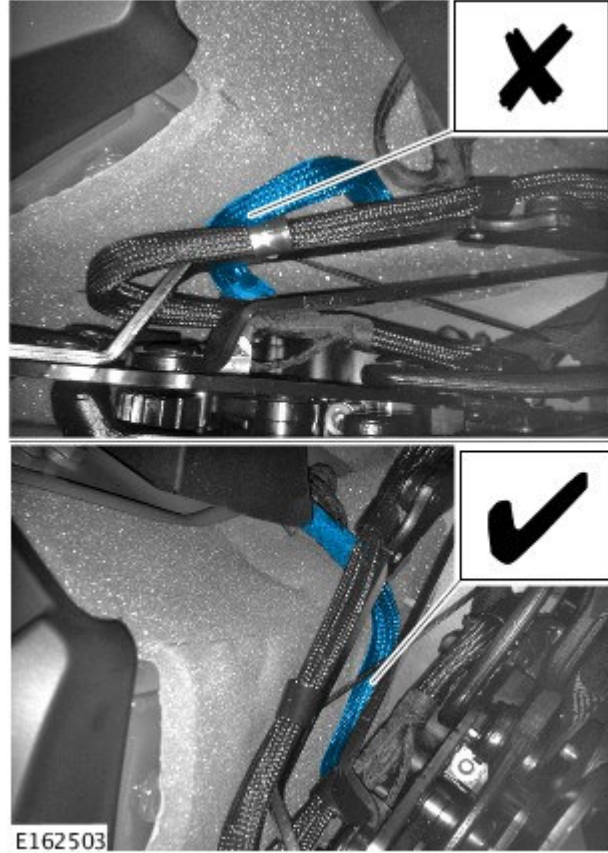
**NOTE: Left-hand harness shown.**

Inspect the left-hand harness; make sure left-hand harness is looped below the link and pulled down rather than trapped between the link and the foam.

- If the harness is routed correctly, continue to Tape Header Trim.
- If the harness is not routed correctly, disconnect the harness to manipulate it to the correct position..

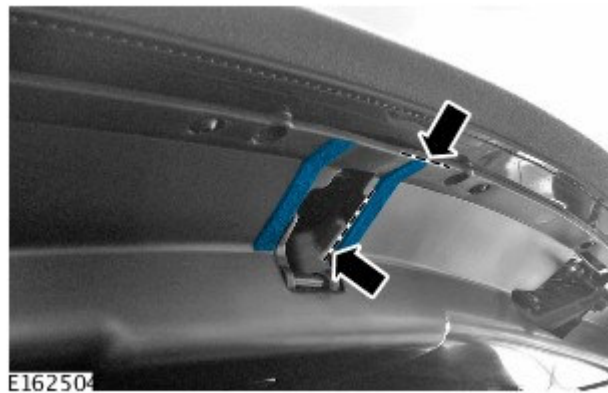
1. When in the stowed (open) position, the folding top may contact the flaps in the corner.
2. The routing of the folding top harness may cause fouling on the folding top mechanism to wear through the braiding.
3. As a result of normal opening / closing of the folding top, the lower header trim contacts the carpet bezel. This contact, over time, may result in white marks on the header trim.

- 10.** Install the tape to align with front edge of header trim and edge of hole feature.
