SB-10056432-3889

Reference	SSM71937
Models	Range Rover / L405 Range Rover Sport / L494
Title	Steering Rack / Tie Rod Damage Identification
Category	Chassis
Last modified	08-Aug-2014 00:00:00
Symptom	303000 Steering/Handling
Attachments	Tie Rod and Seat Material Damage Identifcation.pdf
Content	<p><u>Issue:</u> Customer reports vehicle steering is stiff or a noise is coming from the steering gear internals. There may be no fault codes or warning lights present.</p> <p><u>Cause:</u> Side impact to the vehicle wheels.</p> <p><u>Action:</u> If there is a steering fault (Stiff or internally Noisy), and it is suspected this may have come from accident damage inspect the steering gear and vehicle for signs of impact damage paying particular attention to the following:(These external symptoms correlate to internal damage, but both may not always be present, due to the type of impact)</p> <p>Tie-rod bending (see pictorial help)</p> <ul style="list-style-type: none">• Damage of seat material at inner tie-rod joint (see pictorial help) <p>If no damage is found, ensure the correct boots and clips are accurately replaced to prevent water ingress. (see Microcat)</p>

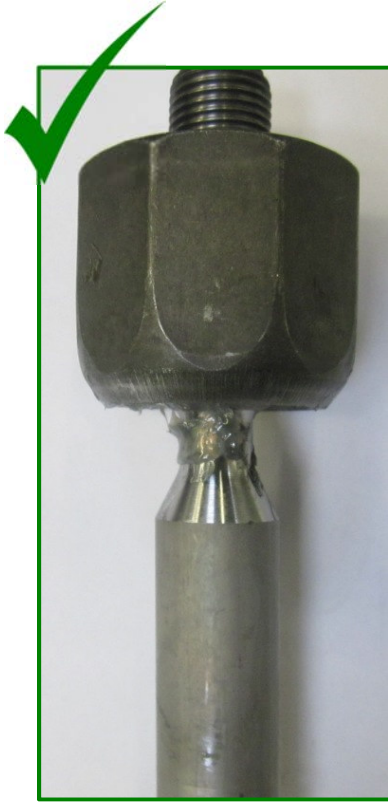
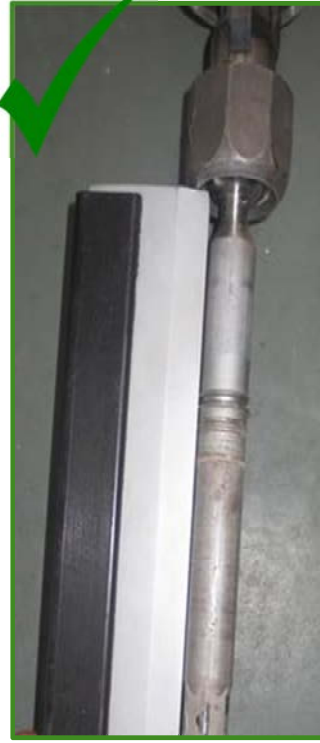
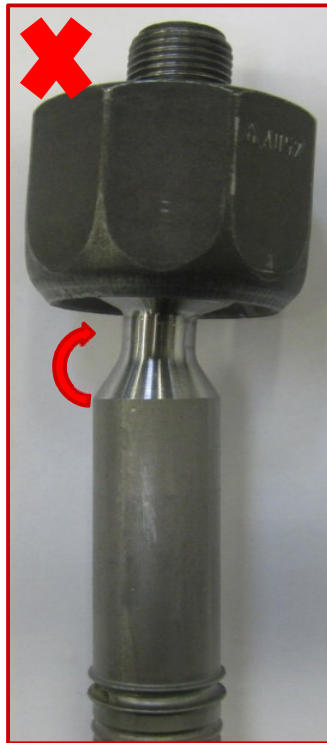
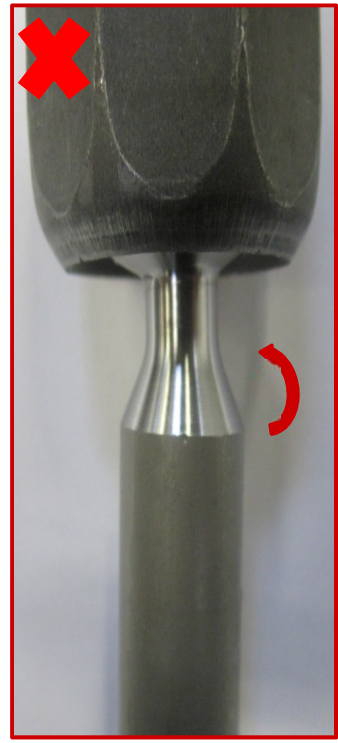
Tie Rod Bending:

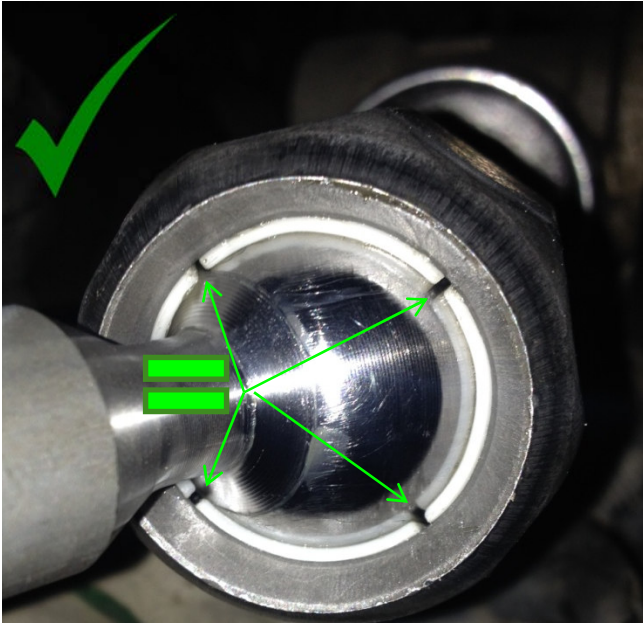
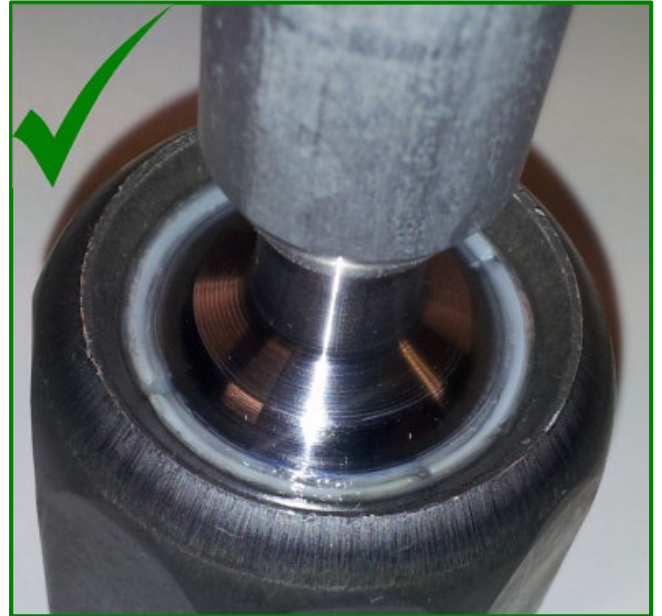
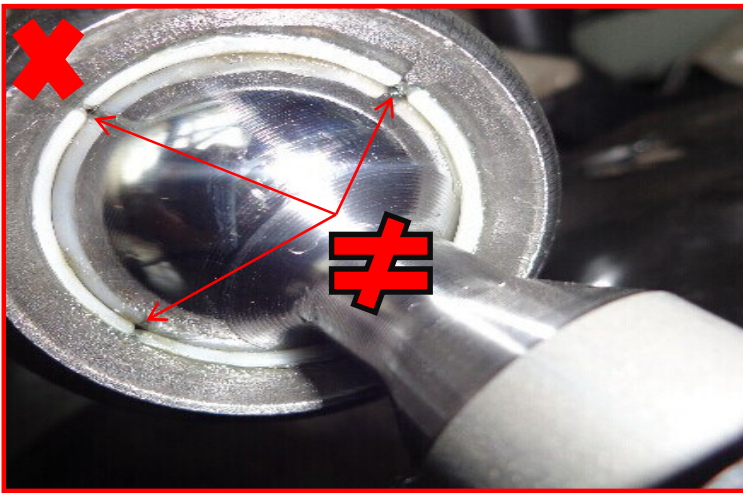
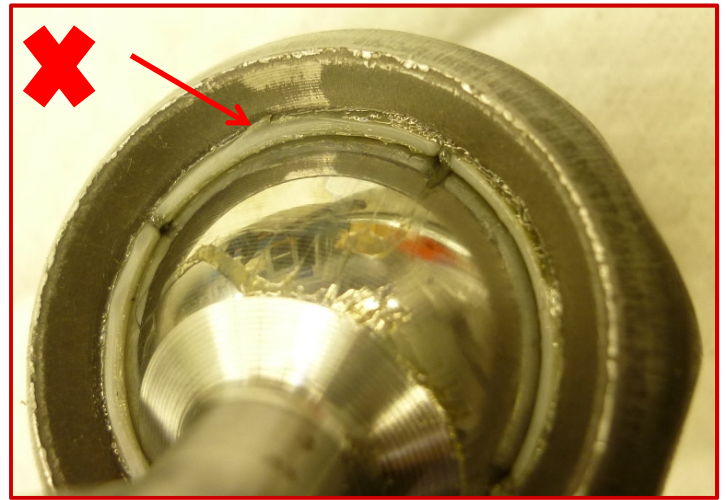
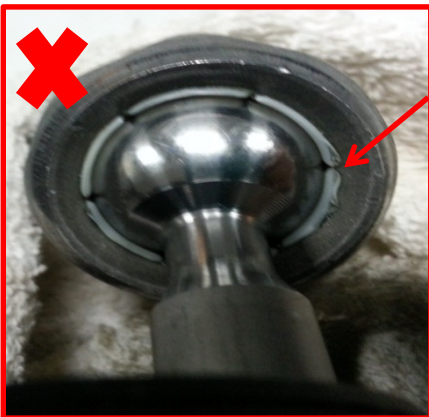
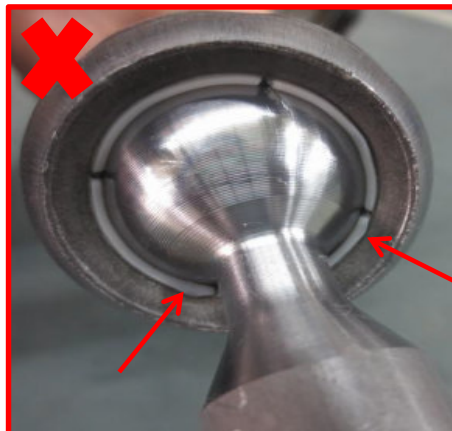
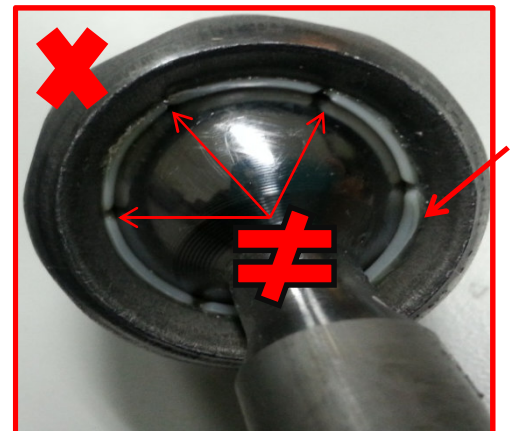
Damage of seat material
