**SB-10056433-5627**

<b>Reference</b>	SSM71958
<b>Models</b>	Range Rover / L405 Range Rover Sport / L494 Range Rover Evoque / L538
<b>Title</b>	Diagnostic process when drivers airbag warning light is illuminated
<b>Category</b>	Body
<b>Last modified</b>	26-Aug-2014 00:00:00
<b>Symptom</b>	104000 Restraint Systems
<b>Attachments</b>	Locking Tab Photos (6).pdf

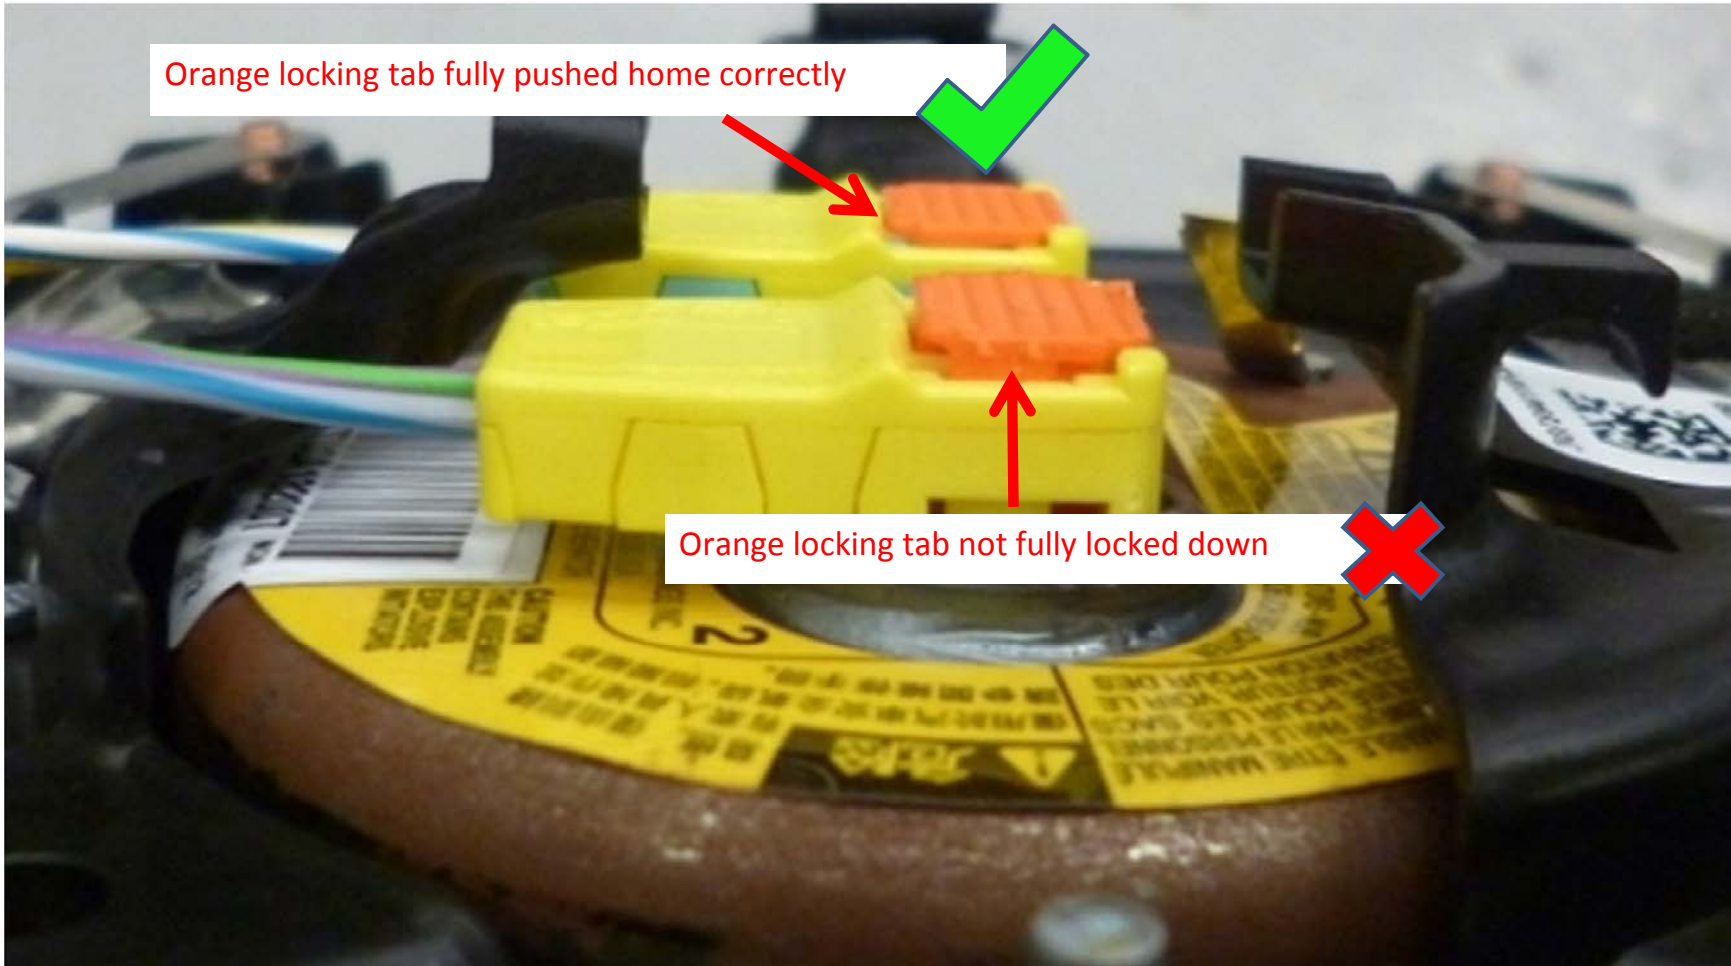
The clock spring connectors have not been latched correctly. See attachment

Orange locking tab fully pushed home correctly

Orange locking tab not fully locked down

The work shop manuals have been updated for the following Restraints Control Module (RCM) DTC codes to inspect the connectivity of the clock spring connector.
