Technical Service Bulletin

21E7 UPDATE – Turbocharger (NVLW)

SB-10056439-1712

Model(s)	Year	VIN Range	Vehicle-Specific Equipment
A3	2015	See Campaign/Action screen in Elsa	CNTC (2.0L)

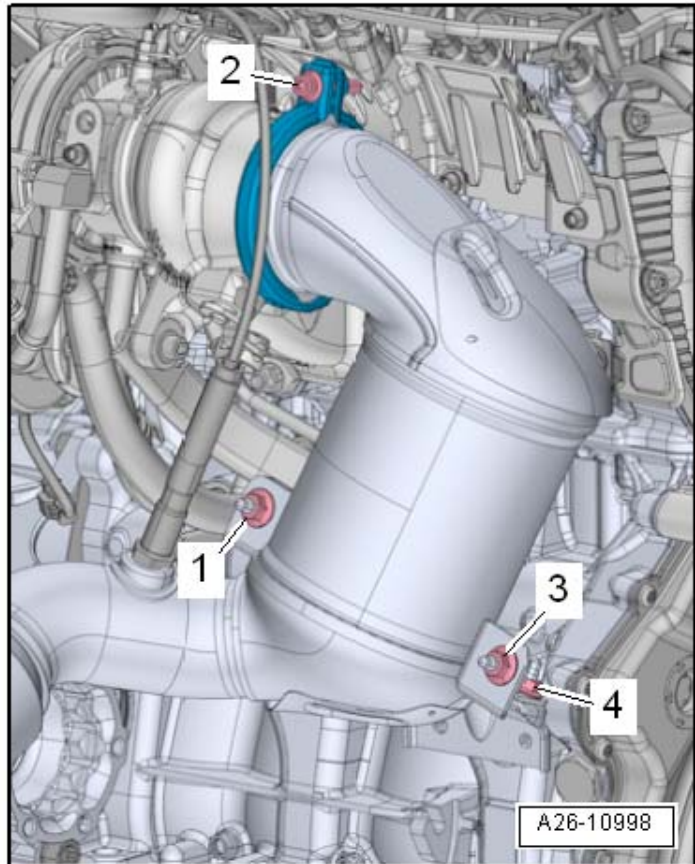
The installed position is shown in the illustration with the engine removed.

- Drain the coolant.
- Remove the air filter housing.
- Remove the Heated Oxygen Sensor - G39-
- Remove the bolt <2> and the screw-type clamp.
- Remove the nuts <1> and <3> and move the catalytic convert to the side. Ignore item <4>
