Technical Service Bulletin

SB-10056445-5335

94 Headlight internal diagnosis before replacement, various concerns

Model(s)	Year	VIN Range	Vehicle-Specific Equipment
A6	2011 - 2015	All	Not Applicable

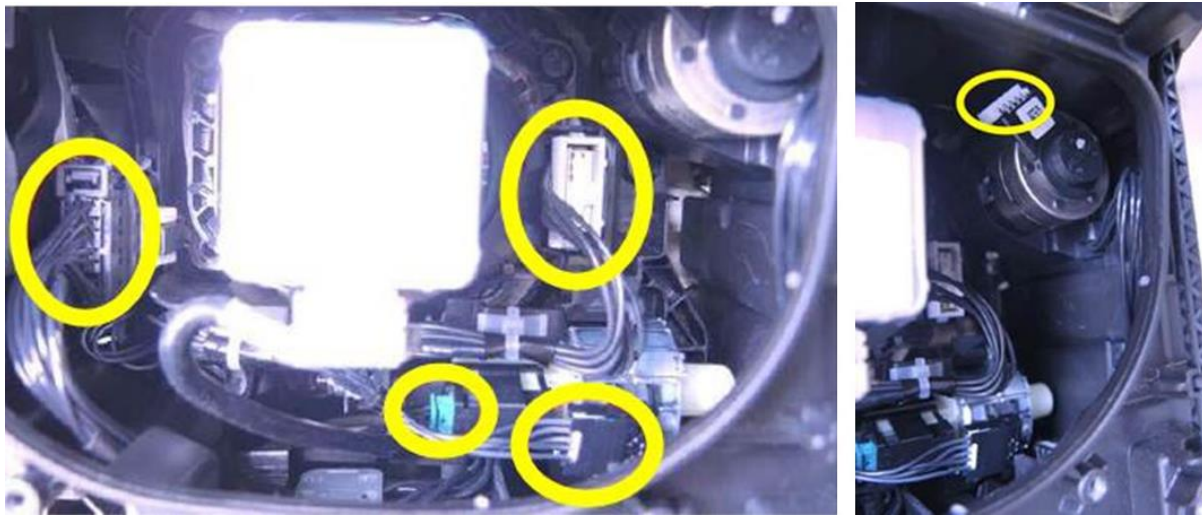
For symptom A (Cornering light and/or headlight range control inoperative):

Figure 1. Check these connectors on vehicles with PR codes 8Q3, 8Q5, and 8Q7.

- If the vehicle is equipped with one of the following PR codes, check the connectors shown below (Figure 1):
 - **8Q3** (Automatic headlight-range adjustment dynamic (self-adjusting while driving))
 - **8Q5** (Headlight-range adjustment automatic/dynamic with dynamic bending light(AFS 1))
 - **8Q7** (Headlight-range adjustment).

3. If any connectors are not correctly plugged in, check connector for damage. If no damage is found, reconnect the connector. Do not use a screwdriver or other metal object. If all connectors were plugged in correctly, this bulletin does not apply.
4. Reconnect the headlight to the vehicle, then check the headlight operation. It is not necessary to fully install the headlight to test the headlight operation.
5. If headlight operation is fully restored, fit and adjust the headlight. Additional adaptations (radar sensor, overhead camera, night vision) may be necessary, depending on vehicle equipment.

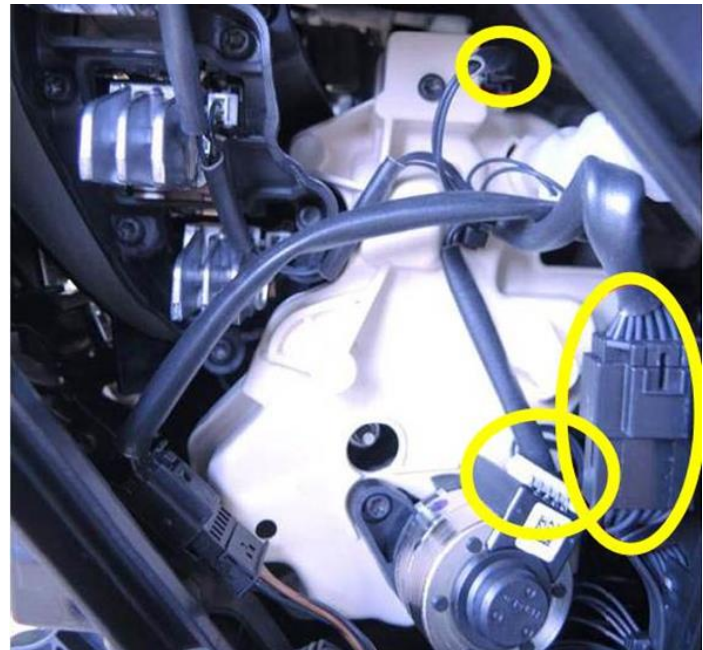
Figure 2. Check these connectors on vehicles with PR codes 8EX and 8EY.

- If the vehicle is equipped with one of the following PR codes, check the connectors shown at right (Figure 2):
 - **8EX** (LED headlights)
 - **8EY** (LED headlights)

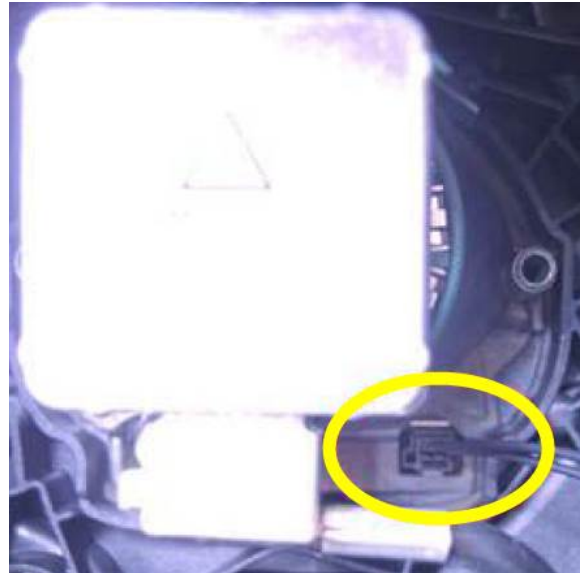
For symptom B (Xenon high beam inoperative):

Figure 3. Check this connector (connector at high beam shutter) on vehicles with PR codes 8Q3 and 8Q5.

- If the vehicle is equipped with one of the following PR codes, check the connector at high beam shutter shown at right (Figure 3):
 - **8Q3** (Automatic headlight-range adjustment dynamic (self-adjusting while driving))
 - **8Q5** (Headlight-range adjustment automatic/dynamic with dynamic bending light(AFS 1))
